**A Culture at Risk:
An Initial Assessment of Seismic Vulnerabilities in Upper
Dharamsala, India**

Submitted to the Flora Family Foundation

October 31, 2006

GEOHAZARDS

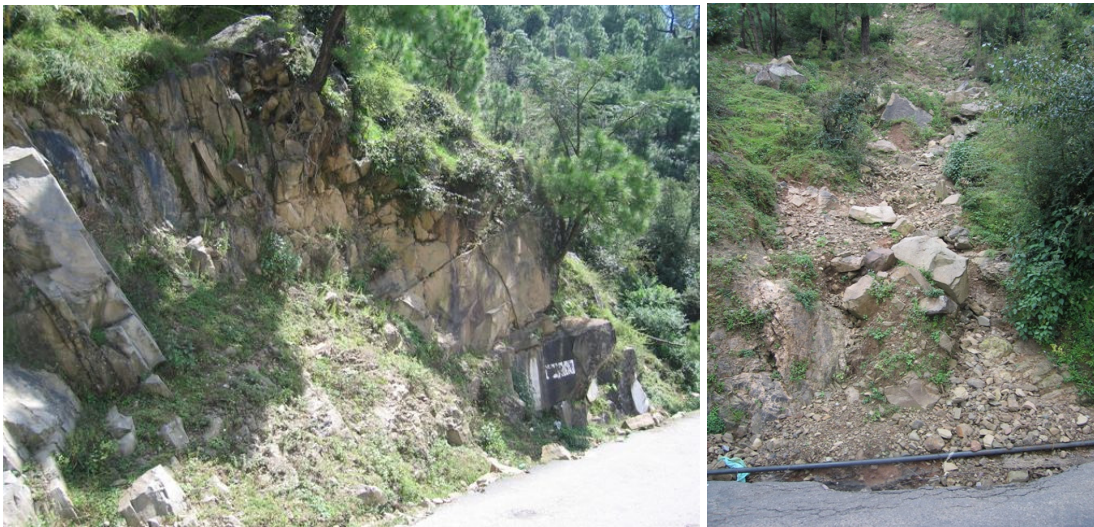
Thick-bedded, resistant sandstone bedrock exposed along the McLeod Ganj ridge (left). Landslide debris exposed on the hillside uphill from the LTWA site (right).

Landslide deposits exist within the colluvial material and display the characteristic topographic expression of failing ground, shown above. The formation of a landslide within a colluvial slope requires the development of a below-ground slip surface along which the landslide is displaced down slope. Once formed, a slip surface provides a weak link that is vulnerable to future triggering events such as heavy storms or strong earthquake shaking.

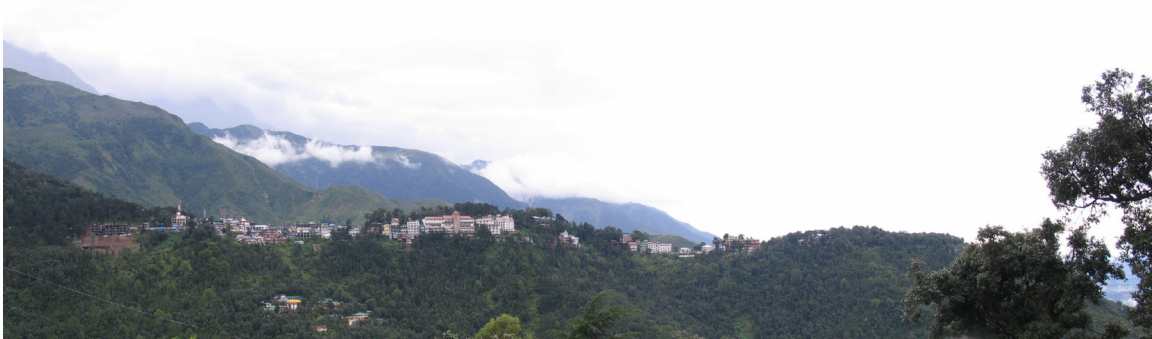
McLeod Ganj viewed from the west, with the Dhauladhar range to the north (left of the photo) and the Kangra Valley to the south. Most buildings in this view are along the axis of the ridgeline on relatively stable ground.

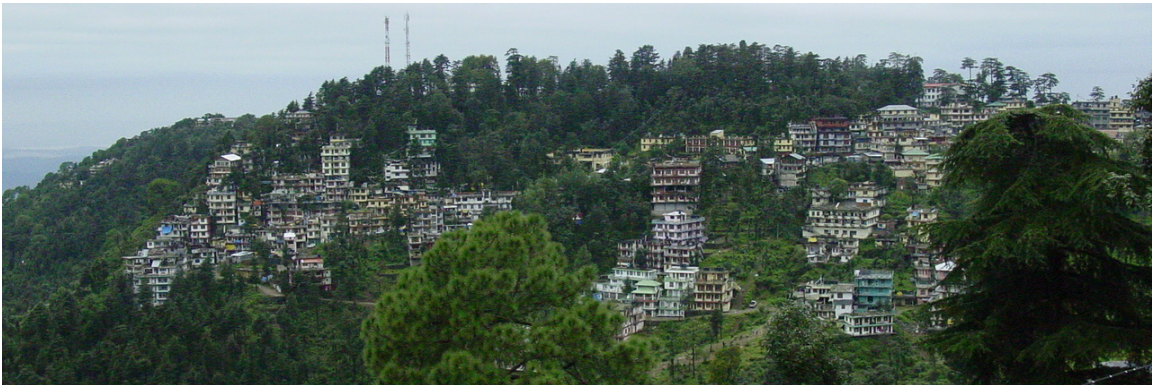
McLeod Ganj viewed from the east. Many of the buildings in this view are on the side slopes of the ridge on relatively unstable ground.

The chance of earthquake-induced reactivation or displacement of the existing landslides is high. Some of the observed landslide deposits are stable, showing no evidence of recent movement, while others show clear signs of recent surface displacement. Roads leading up to McLeod Ganj (i.e., Upper Dharamsala) and many of the buildings on the slopes around the edges of the community are on landslides. The long-term stability of the colluvial slopes and the isolated landslide deposits is unknown. However, the probability of failure is high in a large earthquake and/or during prolonged monsoon conditions.

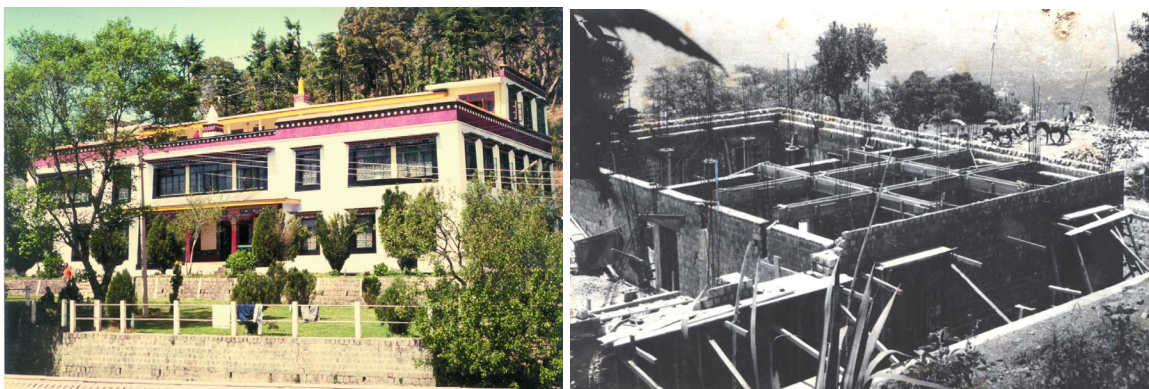
LTWA Main Building (left) and during construction (right). Historical photos courtesy LTWA.

The building is in relatively good condition. There is some water damage on the back wall of the third floor. Exterior seasonal mold during the monsoon is not problematic, but detracts from the aesthetics of the building. Yearly cleaning after the monsoon using an environmentally friendly fungicide might help reduce fungal growth and improve the appearance of the building.

The main building's concrete frame and masonry walls are not likely to have the strength to resist strong earthquake shaking without significant damage. The frame does not have enough properly placed reinforcing steel to resist earthquake shaking without extensive damage. However, the thick exterior stone walls and significant number of interior masonry walls add strength and stiffness to the frame and make it unlikely that the building would collapse. Some interior partition walls, especially those constructed of unreinforced brick masonry, might be prone to out-of-plane failure (bricks might fall into the rooms) that would endanger both occupants and contents located near the wall.

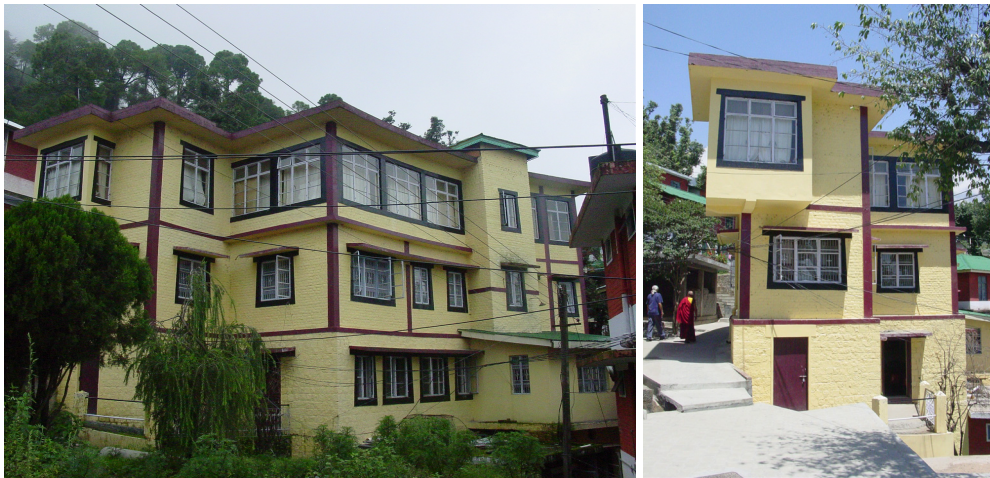
Front and side elevation views of the LTWA annex.

The building appears to be in relatively good condition. There are some cracks, possibly due to settlement, and localized water damage.

The annex has numerous vertical and plan irregularities that are likely to increase earthquake-imposed deformations and lead to damage. The structural system appears weak, with an incomplete frame and thin unreinforced brick walls. The combination of these characteristics, along with the sloping site, makes the annex vulnerable to collapse. The numerous four-inch brick partition walls are likely to fail under strong earthquake shaking, endangering persons and contents inside. An in-depth engineering analysis is necessary to determine the likely behavior of the building and develop possible retrofit schemes. The archives and the material they contain are also in need seismic protection (possibly by relocation).

7. Retrofit the LTWA annex to reduce the chance of collapse, change its use and relocate people and important collections, or demolish and replace it with a new, safer building that meets the functional needs of the library. The LTWA staff should consider relocating some functions currently housed in the annex while deciding what to do with the building.

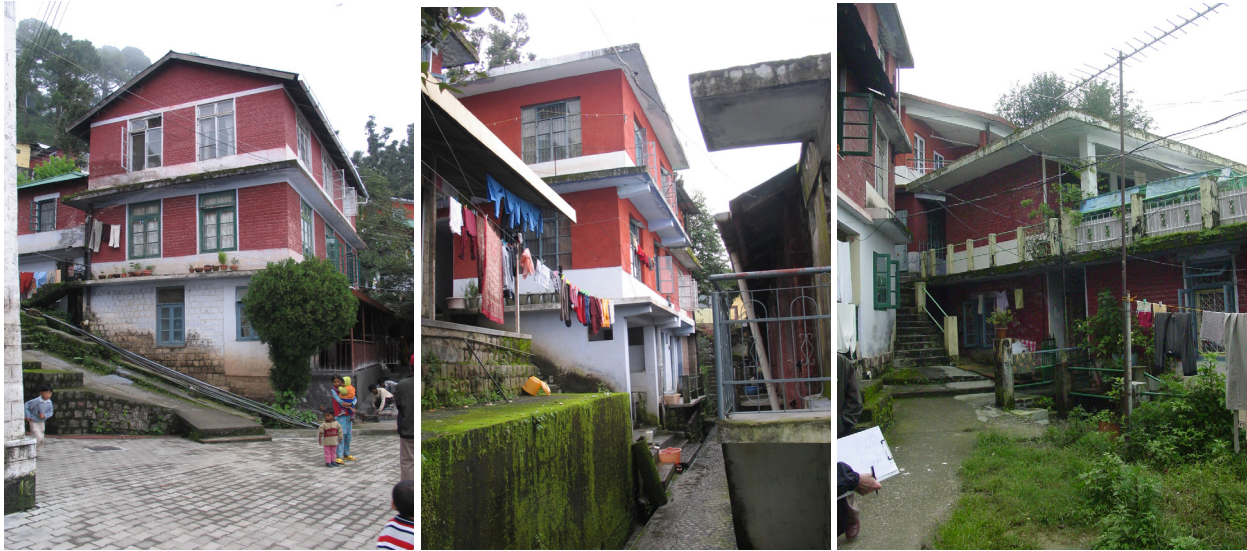
Building 8 (left) is a three-story masonry bearing wall building. Building 19 (center) is a reinforced concrete frame building. Buildings 11, 12 and 12A (right) are masonry bearing wall buildings. The close spacing of buildings makes persons between them in danger of falling hazards.

All of the buildings on the LTWA campus are potentially hazardous during earthquakes and should be evaluated in more detail. Because many of the buildings are similar, a few representative buildings could be evaluated and the results used to decide which retrofit strategies apply to the other buildings of that type. The retrofit methods contained in the Indian building code might be appropriate for most of the small masonry buildings.

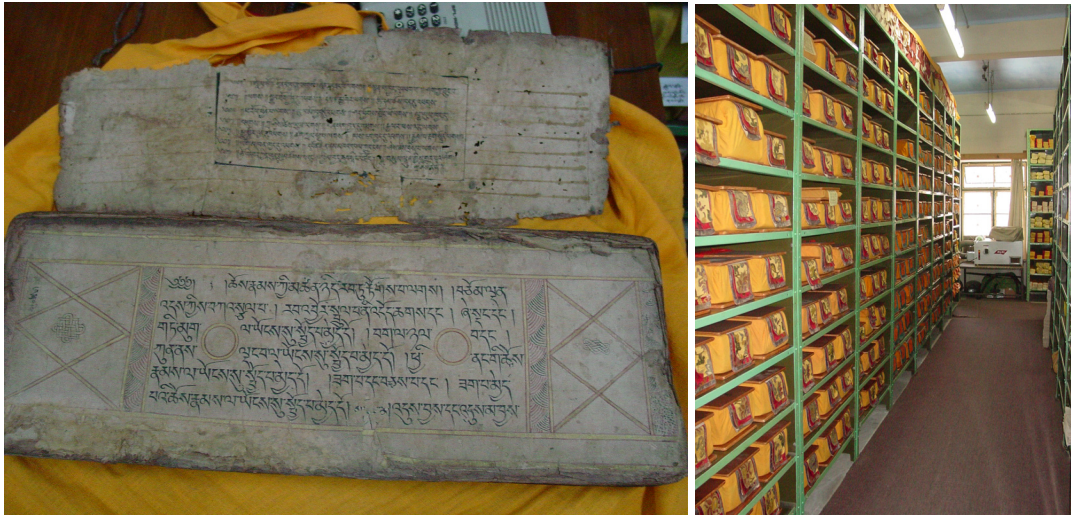
A manuscript written during the thirteenth century (left), and unsecured manuscript storage racks and climate control equipment (right).

The manuscripts are stored in unanchored and unbraced open racks, and there are no shelf restraints. The racks will likely topple and spill the manuscripts, injuring anyone in the room and possibly damaging the manuscripts. Humidity control equipment in the manuscript storage room is unsecured. The water pipes that service the toilet block on the second floor could break and cause water damage in the manuscript room on the first (ground) floor. The second floor plumbing might also pose other, non-seismic threats to objects stored below from such events as backups or overflows.

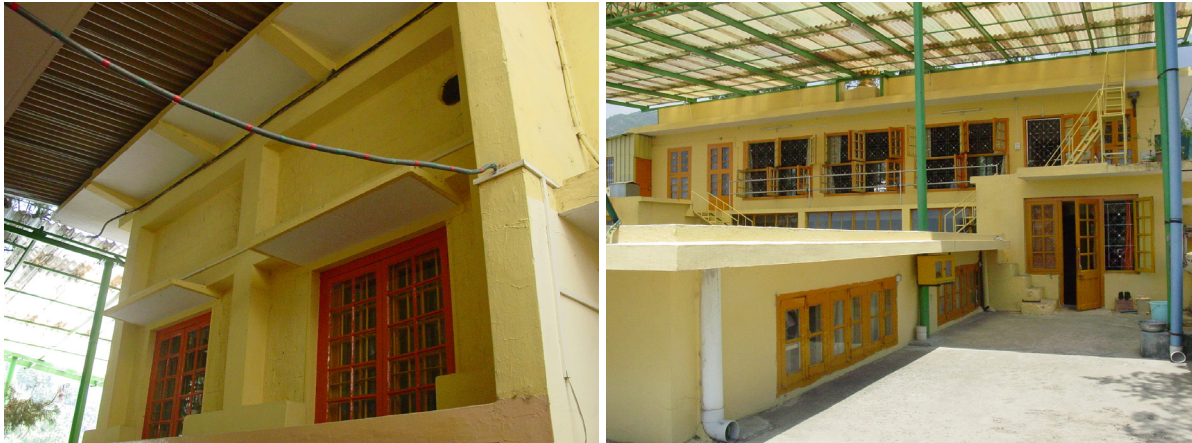
Damage to the temple during future earthquakes is likely because the adjacent canopies are not separated adequately from the temple building, but are not connected to it either. The canopies will pound against the building as they sway during earthquakes. Some of the canopies intersect with the original building partway down the second story walls where pounding damage is potentially more severe because it directly impacts supporting walls and columns. The original building does not have sufficient amounts of properly placed reinforcing steel to resist earthquake shaking, and plain reinforcing steel (meaning it has a smooth surface) was used, which results in a weaker bond between concrete and rebar than the more desirable deformed rebar. Vertical irregularities in the structure also might lead to damage. The temple, canopies and additions must be analyzed together.

Concrete framing added to the side of the original temple building following the 1986 earthquake (left), and intersection of canopy with original temple structure where floors slabs do not align (right).

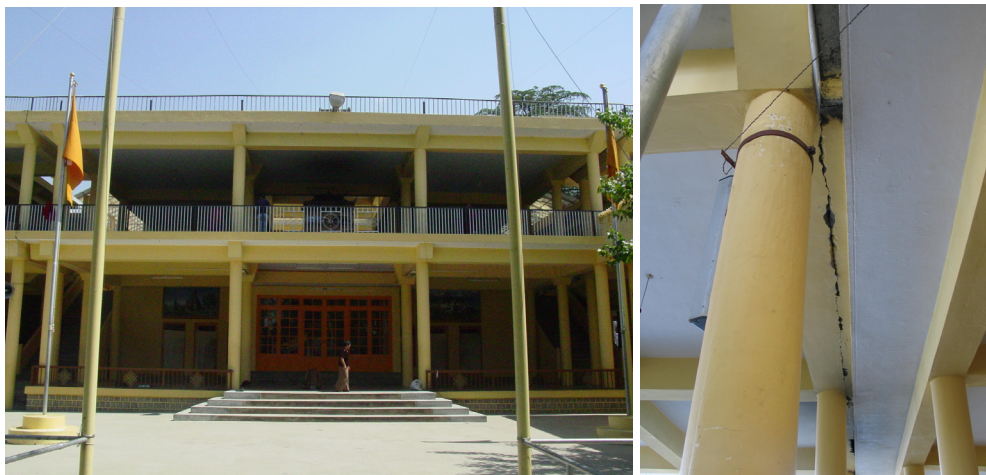
Canopies (left) and minor damage due to differential movement during the distant October 8, 2005 Kashmir earthquake (right).

The canopy structures and additions appear to be in relatively good condition. Very minor cracking and spalling (chipping) was observed at the second story. Minor cracking occurred during the distant October 2005 Kashmir earthquake due to inadequate separation.

- The canopy structures were constructed without adequate seismic separation from either the original temple building or each other. The distant 2005 Kashmir earthquake caused differential movement between the canopies and minor spalling was caused by the pounding. A large earthquake would cause significant pounding damage.

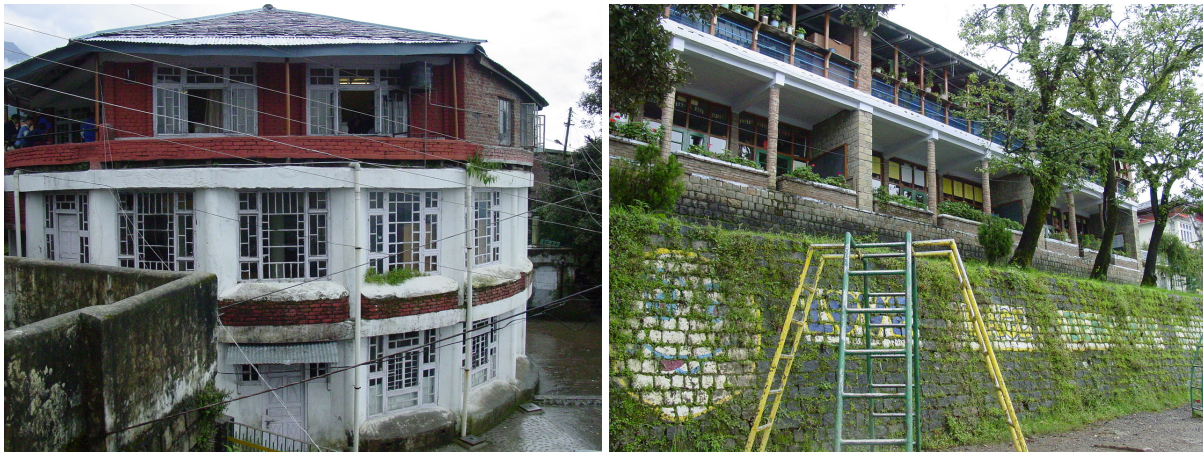
Tibetan children who come from distant places, including Tibet, to receive an education. The assessment team walked through the campus and observed a number of seismically vulnerable buildings. Assessments should be conducted at other area schools that serve the community, since they are also likely to have seismic vulnerabilities. Building collapses and the resulting deaths of children at the TCV and other schools would be devastating from a humanitarian point of view and would present a significant setback to efforts to pass Tibetan culture on to the next generation.

Seismically vulnerable buildings at Tibetan Children's Village.

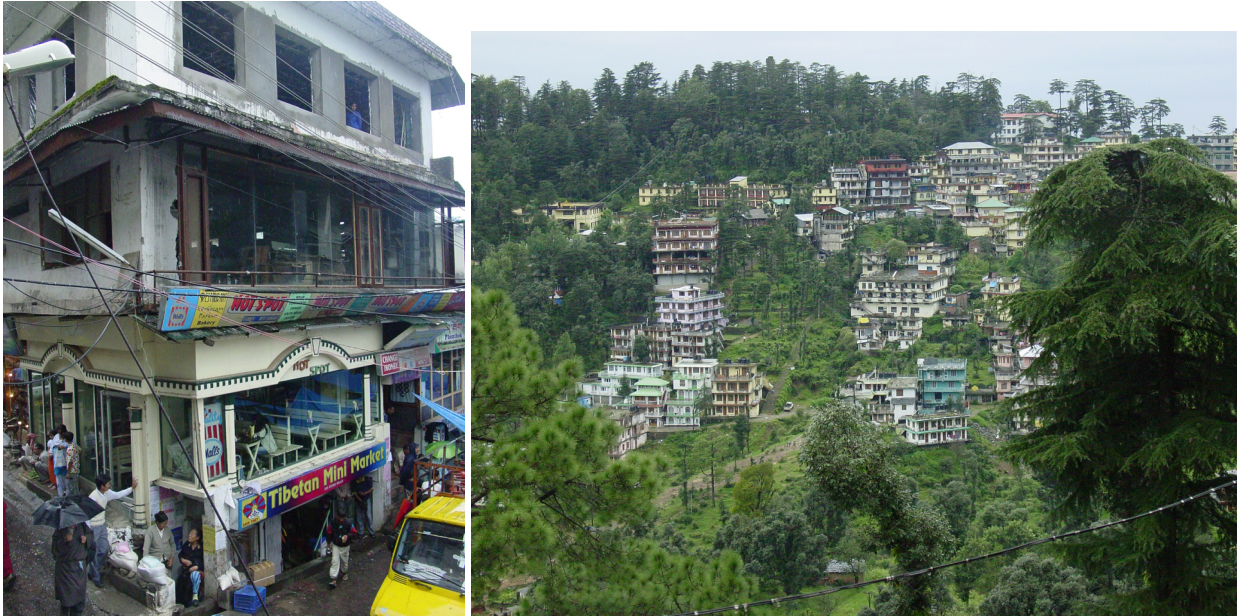
Many of the commercial and residential buildings in McLeod Ganj have significant seismic vulnerabilities. Multi-story reinforced concrete frames with vertical and plan irregularities and without proper seismic details are common. Most buildings have unreinforced brick walls and rooftop water tanks, and many have unbraced masonry parapets. Were these objects to fall during a daytime earthquake when the narrow streets are crowded with people, they would kill many. Construction quality and the quality of materials, especially concrete, appear to be uniformly poor. Many buildings, especially the newer ones, are constructed on slopes prone to landslides. As McLeod Ganj continues to be built out, this situation will only worsen as the more marginal lots are developed due to lack of land elsewhere.

Commercial building with vertical irregularities in McLeod Ganj (left); buildings on hillsides (right).
