Initial Seismic Vulnerability Assessment
of Equipment, Utilities,
Architectural Shell and Contents
at
National Academy of Medical Sciences (Bir Hospital)
Kathmandu, Nepal

July 31, 2013

Prepared for the World Health Organization Regional Office for South-East Asia by

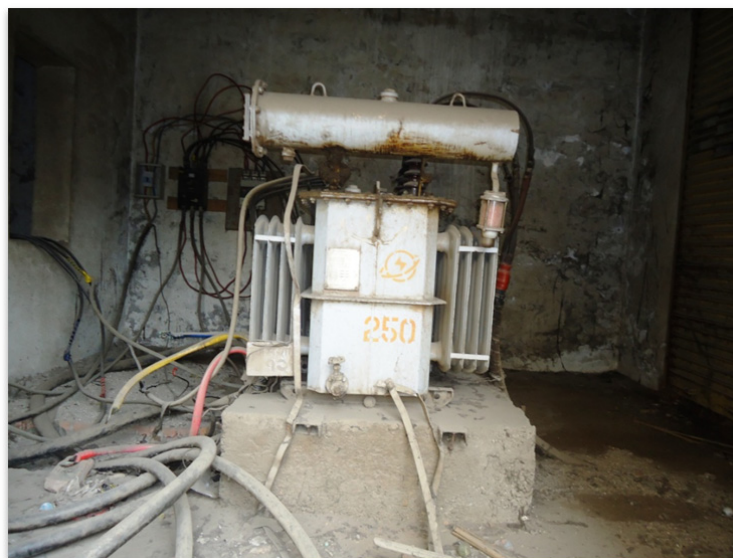
The hospital has two transformers of 250kVA capacity each. The transformers that receive the grid power supply are placed on a concrete platform resting on the floor. The bolting details of the platform could not be determined by visual inspection. There is no evidence of the structure being anchored to the concrete platform with steel plates and anchor bolts; thus the platform is prone to sliding or toppling (Figure 5). Even if grid power returns, the hospital may not be able to access it due to damage to the transformers or their connections to the power lines. During the critical response period immediately following an earthquake, the hospital will need to rely on backup power.

Figure 5: Transformer not secured to the concrete base

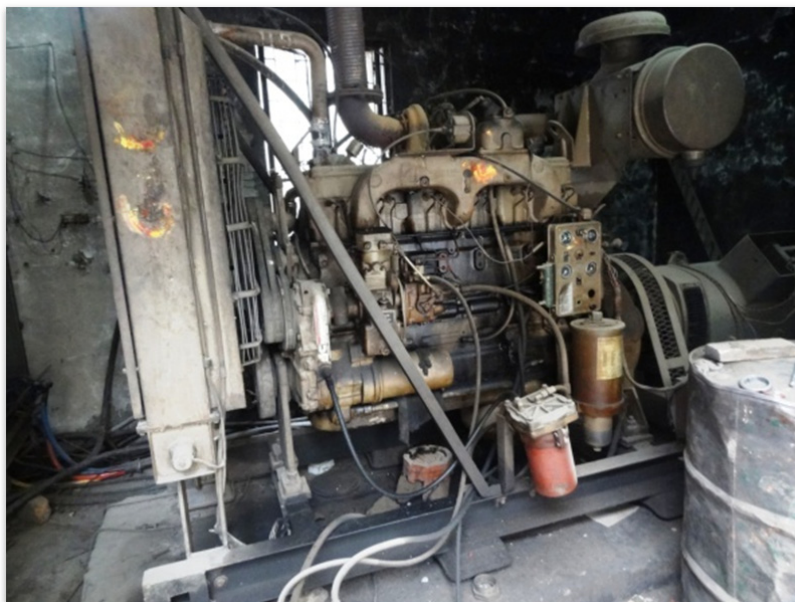
The emergency generator is not anchored and will slide off of the vibration isolators during strong earthquake shaking, as Figure 6 shows. The generator's exhaust system is not braced and may be damaged, which can render the generator inoperable. The batteries that enable the generator to start up are not anchored and may break or become disconnected.

Figure 6: Generator without proper anchoring to the base plate

will not come off their supports, and so that exhaust systems remain undamaged during shaking. Until the new generators and automatic switchover system come online, the hospital should continue the practice of providing all critical medical equipment with emergency backup power independent of the hospital's manually started backup generator. The onsite electrical power backup system is highly susceptible to failure even in moderate earthquake shaking, and it needs significant strengthening to support the hospital's emergency power needs until power supply from the main grid is restored. The hospital should also store the PAHO recommended five days of fuel, or enough to last through the expected length of the grid power outage, whichever is longer. The generator building appears to be unreinforced brick masonry and should receive a structural evaluation.

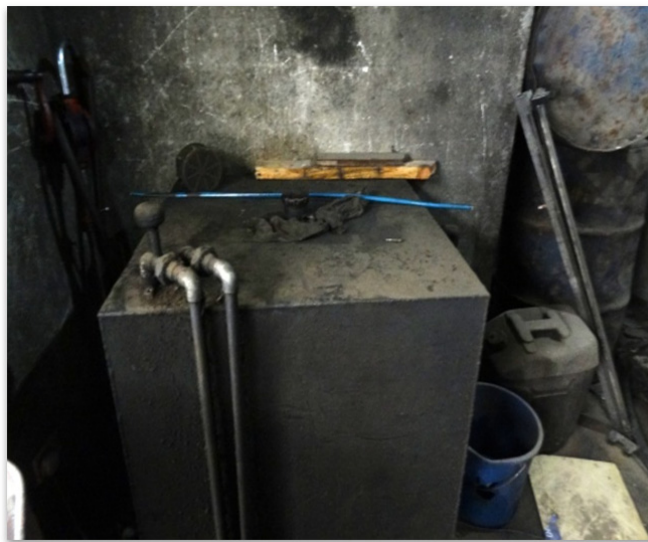
Figure 7: Generator fuel tank without flexible piping

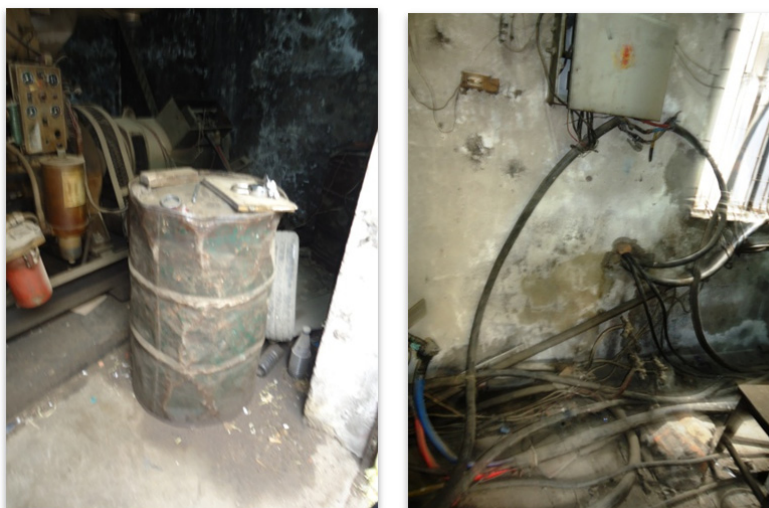
The generator has a tank that holds 500L, and additional fuel is stored in two drums of 200L capacity each. The fuel is procured from a petrol pump located about 4km away. If the tanks and drums are full, the hospital will have enough fuel for 25 hours of operation under normal conditions. PAHO recommends that hospitals store enough fuel to power the backup generators for at least five days. The tank lacks flexible piping, and the supply of generator fuel would be affected if the rigid pipes break during earthquake shaking (Figure 7). The generator is located in a secure place on the ground floor, safe from the elements, but not protected against earthquake shaking. The hospital has no history of being affected by flooding from the nearby rivers. The fuel drums are located in a secure location but are not anchored to prevent toppling and spillage during an earthquake (Figure 8, left). Cables are placed haphazardly and not laid on cable ducts (Figure 8, right).

Figure 8: Reserve fuel drum without anchoring, susceptible to toppling and spillage and posing a fire hazard (left); No ducting or trays for electrical cables (right)

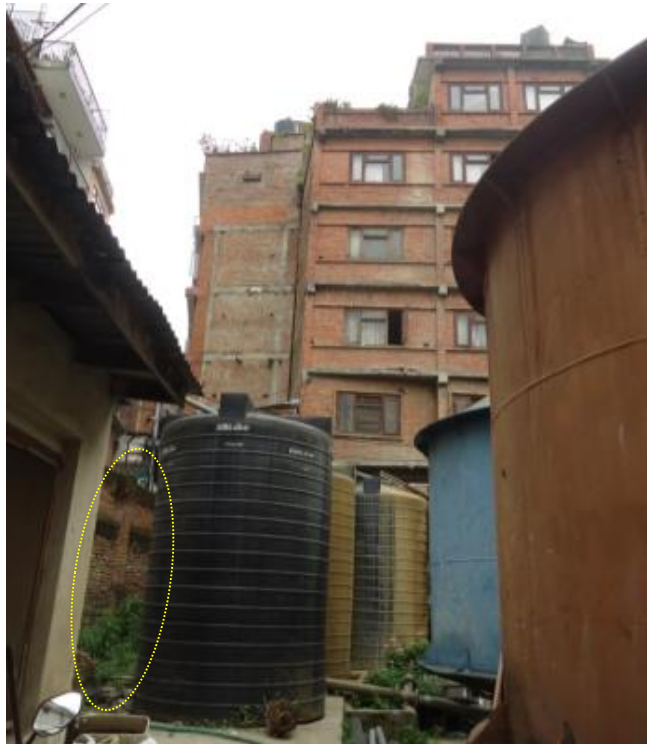
Figure 9: Unreinforced brick masonry boundary wall may topple due to out-of-plane forces and cause damage to the water storage tanks

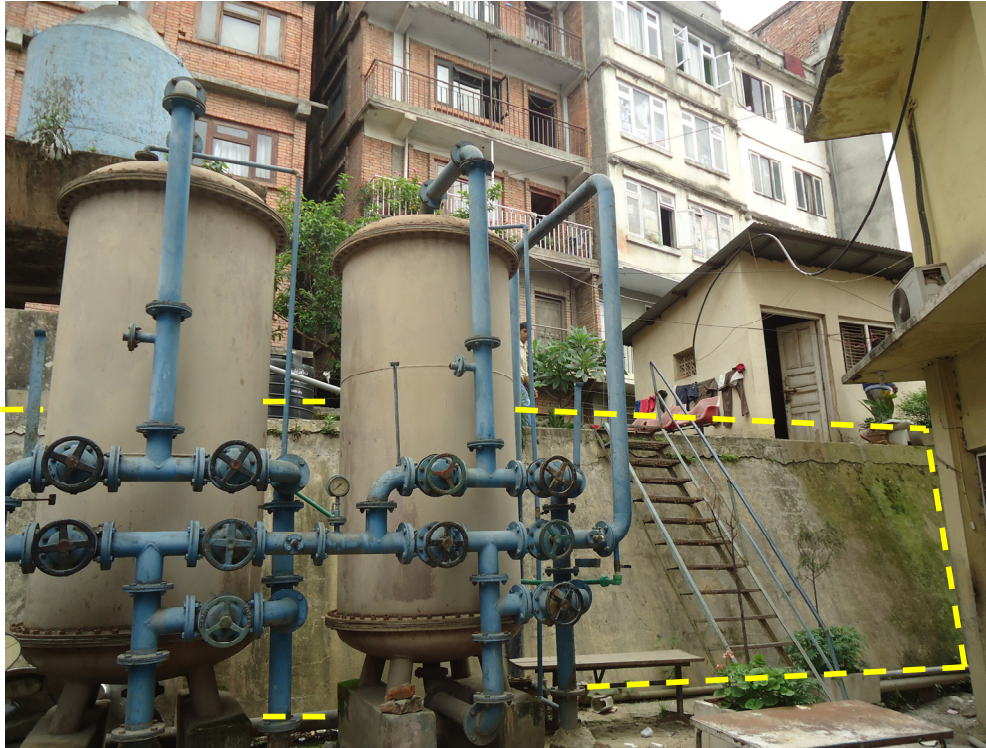
The water treatment equipment is located in an open, easily accessible area near the southwest corner of the wedge-shaped New Cabin Block building (see site plan in Figure 2). The water storage tanks for treated water are located quite close to the boundary wall of the hospital. This unreinforced brick masonry wall does not have any bracing elements to help resist out-of-plane toppling (Figure 9). If this boundary wall collapses, it could in turn damage or topple the water storage tanks and impair water supply to the hospital. Untreated water is stored in a ground level reinforced concrete water tank with 250,000L capacity (Figure 10). The tank appeared to be in reasonably good condition.

Figure 10: Ground level reinforced concrete water storage tank shown by yellow dashed line

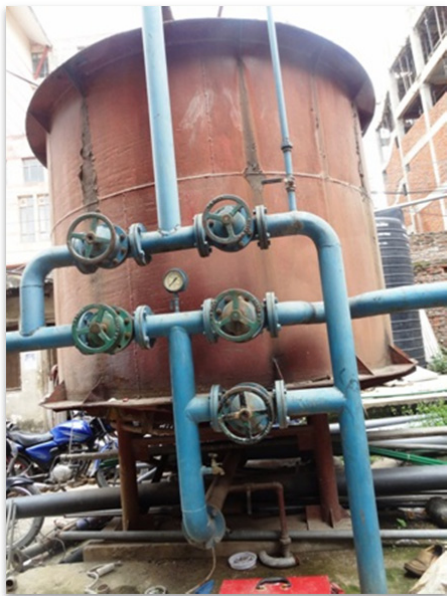
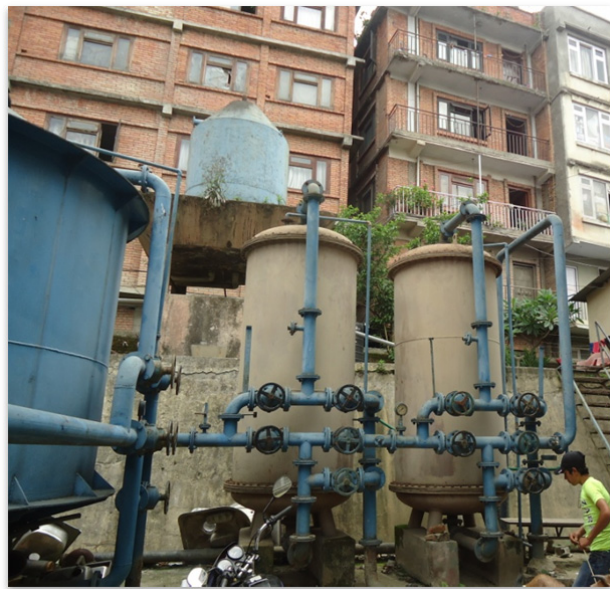
The untreated water is subjected to four levels of treatment, namely, sand filter, carbon filter, ammonia removal and softening. The four treatment tanks are GI (Galvanized Iron) tanks with rigid inlet and outlet pipes, and with no flexible connectors that would protect against breakage during earthquake shaking (Figure 11).

Figure 11: Rigid piping in sand filter tank (left);
Rigid pipes in carbon filter, ammonia removal and softening tanks (right)

Overhead (rooftop) tanks need anchoring to prevent sliding or toppling in moderate to severe earthquake shaking. Anchor water treatment equipment to prevent damage that would disable the treatment system. Replace rigid connections to the water tanks and to filtering/ water treatment equipment with flexible connections, to accommodate differential movement and prevent breaks that could drain the tanks. Water supply lines crossing building joints should have flexible connections at the joints sufficient to accommodate the expected amount of differential displacement.

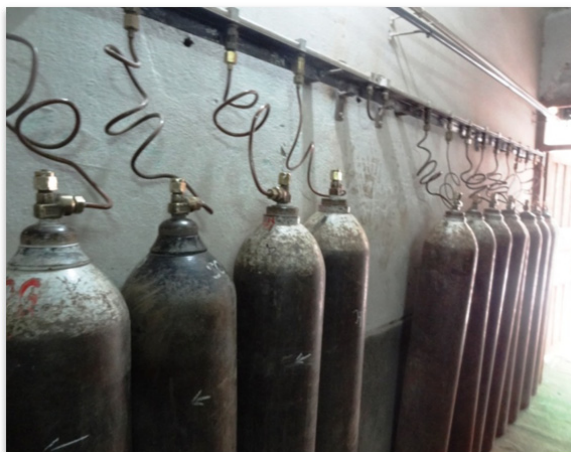
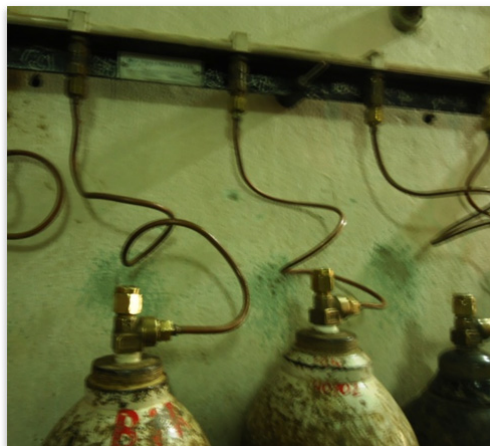
The oxygen bank does not have a large tank, but instead uses a manifold with 30 unanchored cylinders that are connected to it by semi-flexible copper tubing (Figure 12). During an earthquake, many of these cylinders will topple, disconnect from the manifolds, and possibly leak, leading to a possible fire and explosion hazard. The Hospital has a daily requirement of 60-80 oxygen cylinders, but has storage space for only 30 cylinders (in addition to the 30 cylinders in the manifold), which means there is only half a day's supply of oxygen or less. While the piping is secure, there is no flexibility where the lines cross expansion joints and extend into a different building (Figure 13). This lack of flexibility may cause damage during lateral shaking. The medical gas storage facility is accessible, and the cylinders and related equipment are fairly well protected from hazards other than earthquake damage; trained personnel operate the dedicated gas storage area. However, the earthquake hazard is significant because the medical gas storage building is an unreinforced masonry building, which may be damaged during earthquake shaking and disrupt the oxygen supply system. Oxygen and other medical gas cylinders are not restrained in any of the storage locations in the hospital (Figure 12, Figure 14).

Figure 12: Unanchored gas cylinders connected to manifold through flexible piping

Cylinders in the oxygen bank, outside the Burn Ward and in other locations, need restraints to prevent them from toppling during earthquake shaking. At present the hospital does not have adequate backup supply of oxygen cylinders to last more than half a day of normal use. There should be provisions for storage of at least five days' supply within the premises. (Even though PAHO recommends a 15-day supply of medical oxygen, the lack of storage facilities at Bir may make it difficult to store the recommended 15-day supply on site.) Medical gas lines crossing building joints should have flexible connections.

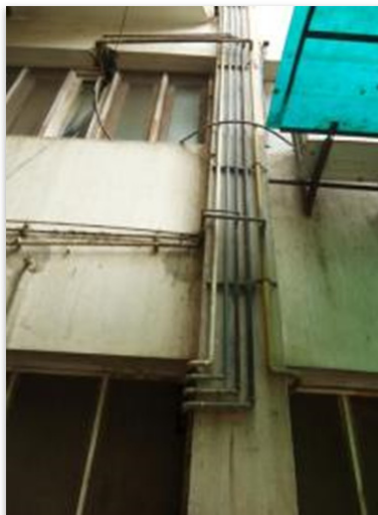
Figure 13: Lack of flexible connections at gas pipe bends

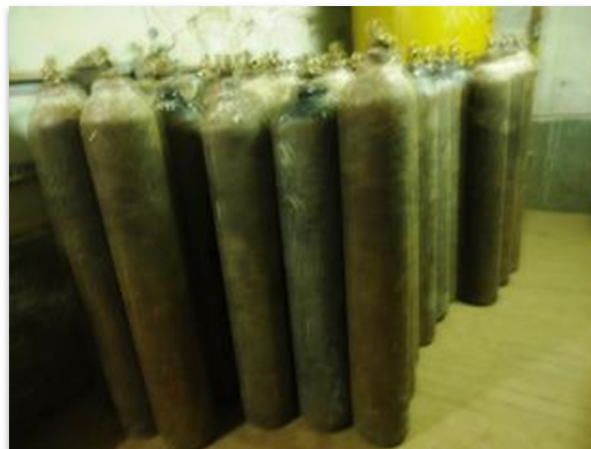
Figure 14: Unrestrained oxygen cylinder storage

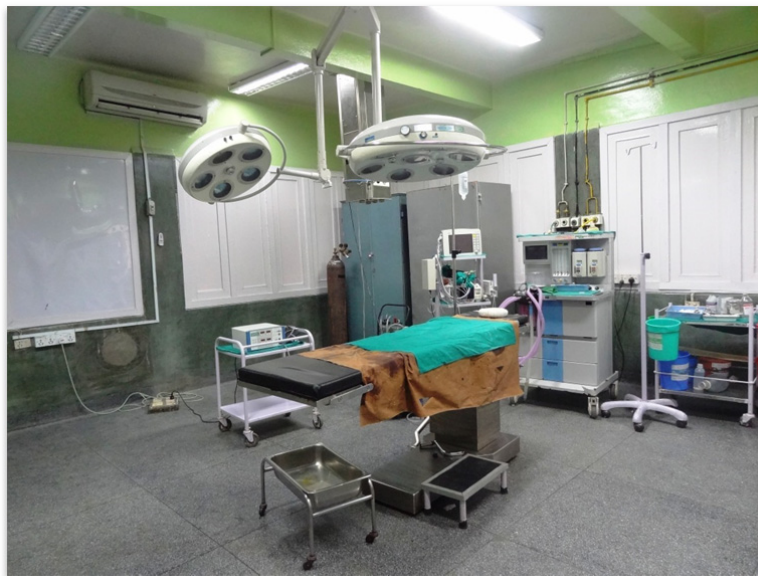
Many of the medical equipment and storage systems have not been secured or anchored for protection against earthquake shaking. In the Operation Theatres and Post-Operative Wards, lamps, anesthesia equipment and surgical tables are in fair condition and operational. However, not all of the equipment is properly secured (Figure 15).

Figure 15: Operation Theatre with OT lights, equipment and surgical table

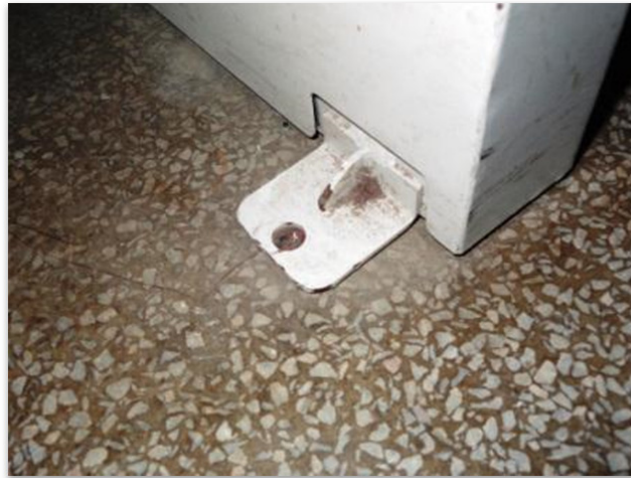
Figure 16: X-Ray machine bolted to the floor.

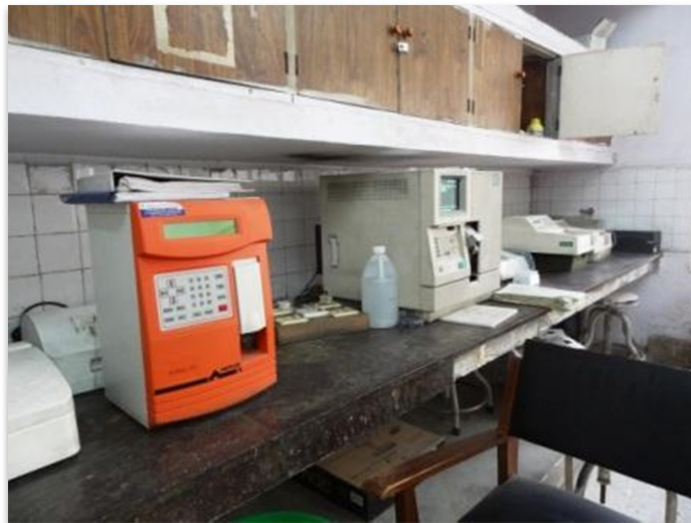
Figure 17: Table top medical equipment without anchoring or restraining

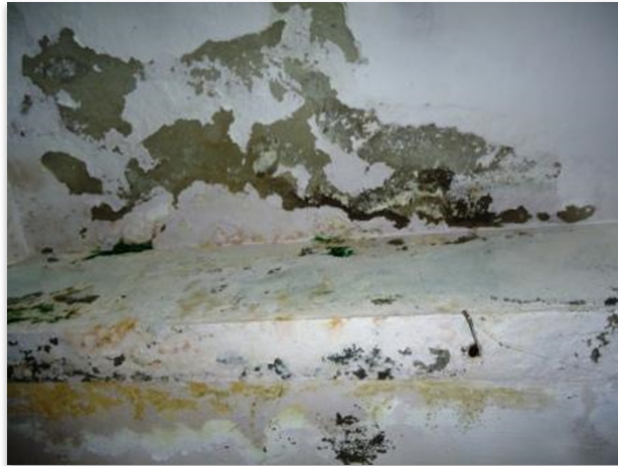
Figure 18: Seepage in the Emergency Laboratory

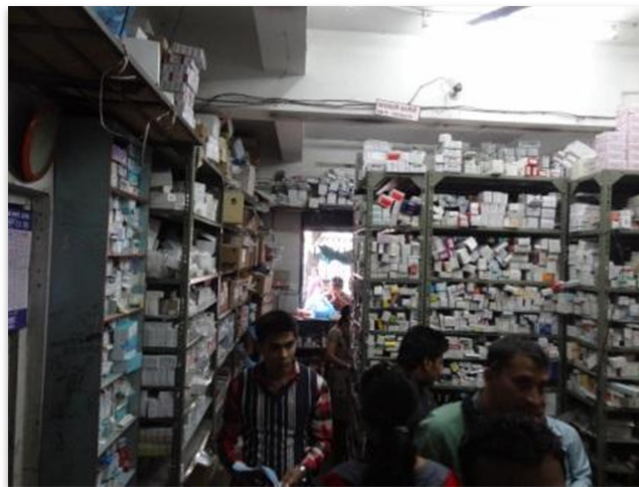
Figure 19: Unanchored shelves with unrestrained contents in the pharmacy

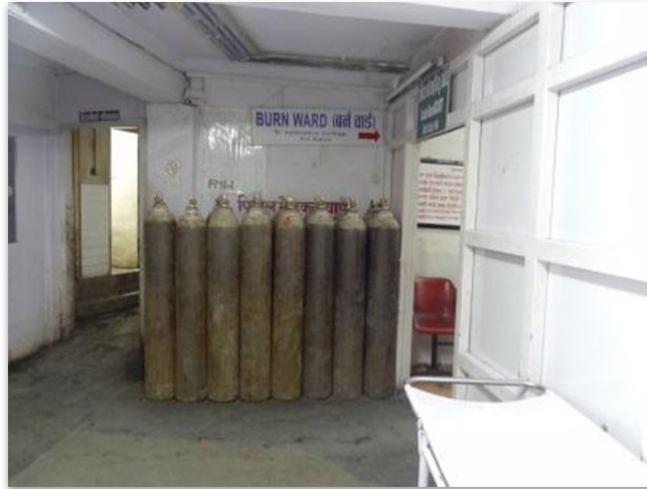
The Burn Unit has nine beds and the equipment is in fair condition but not adequately secured. Many oxygen cylinders that are not restrained by any means (Figure 20) are stored at the entry to the Burn Unit. These would topple in an earthquake and block the exit from the Burn Ward. A major concern regarding the Burn Unit is its location in the New Cabin Block, an unreinforced masonry building, a type of building that has behaved poorly in previous earthquakes.

Figure 20: Unrestrained oxygen cylinders at the entrance to the Burn Ward

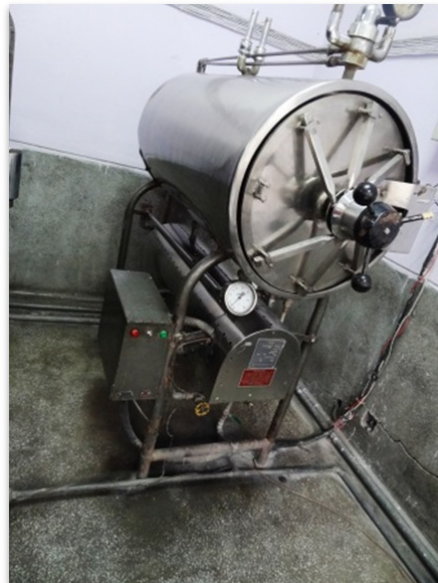
The Central Sterile Supply Department (CSSD) located in the ground floor of the Surgical Block has two autoclaves at risk of functional failure due to earthquake damage, which would leave the hospital without a way to sterilize surgical instruments. The autoclaves are not bolted to the floor or fastened to the walls (Figure 21), and might overturn and suffer damage during strong shaking. The rigid piping will likely be damaged in significant shaking and affect the functionality of the CSSD (Figure 22). Even if anchored, the autoclaves would stop functioning in case of grid power failure, because they are not connected to the hospital's backup power supply system. Though the OTs have full power backup, operations could not be performed without sterile supplies.

Figure 21: Autoclave in CSSD not bolted to floor or anchored to wall

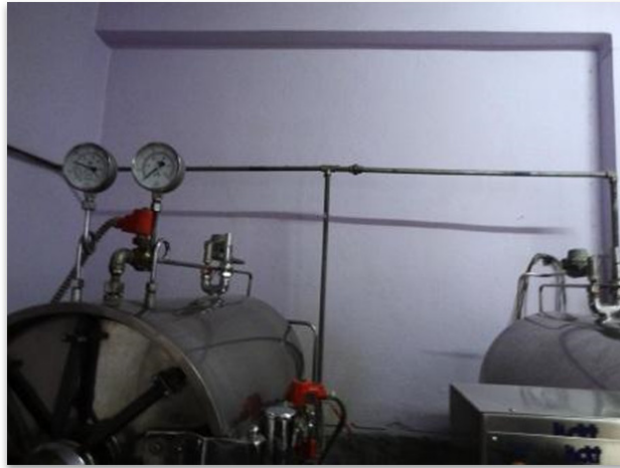
Figure 22: Rigid piping in autoclaves

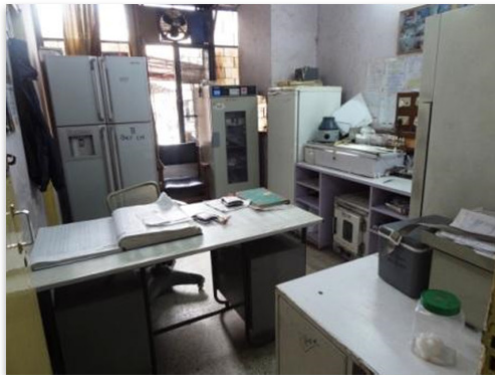
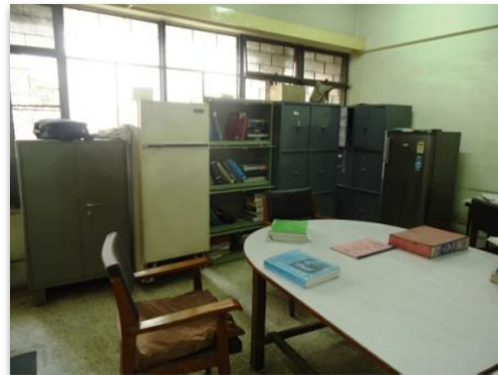
In all the treatment and diagnostic facilities surveyed, the work tables, computer tables, laboratory shelving, and storage units are not adequately secured or fastened for protection against lateral shaking (Figure 23). Moreover, in numerous locations, tall shelves full of glass contents are placed next to exit doors. They will likely topple in an earthquake, spilling their contents and broken glass on important evacuation routes (Figure 24).

Figure 23: Unrestrained furniture and equipment susceptible to toppling and sliding

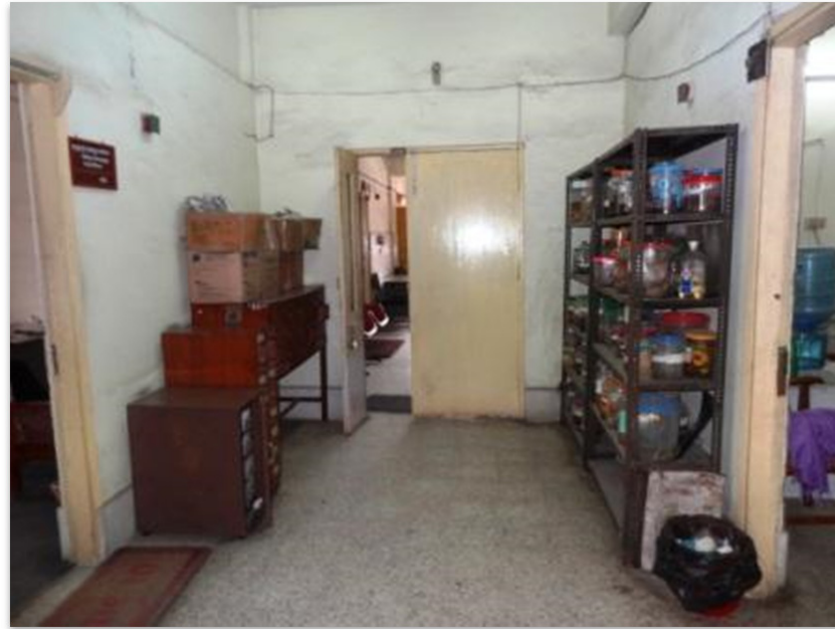
Figure 24: Unsecured shelves with pathological contents susceptible to breaking, spillage and blocking of exit routes

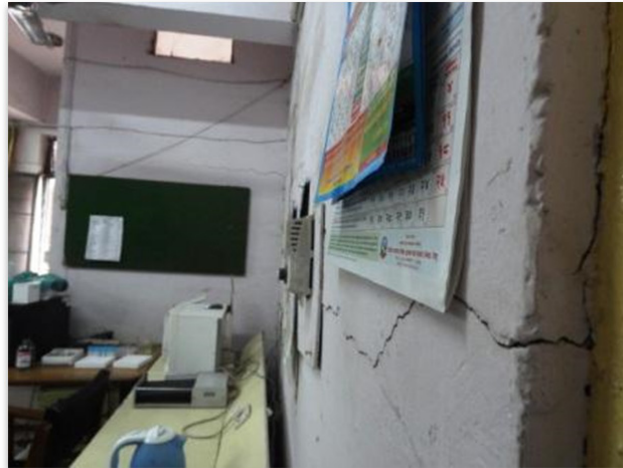
The 230mm thick floor-to-ceiling brick infill walls separating the different functional spaces in the Emergency Laboratory and Blood Bank have floor-to-ceiling cracks, both transverse and diagonal, indicating possible mild distress in these walls (Figure 25). This needs to be thoroughly investigated through non-destructive testing to ascertain the strength and condition of the materials and the adequacy of the infill walls. Weakness here could significantly affect the Emergency Department's ability to deliver care post-earthquake, because collapse of these infill walls during shaking would render the Blood Bank and Emergency Laboratory in-operational.

Figure 25: Infill walls with long continuous cracks in the Emergency Lab and Blood Bank

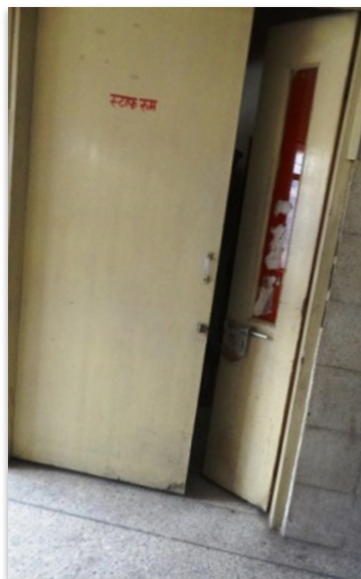
Figure 26: Narrower leaf of door kept open while wider leaf is kept shut

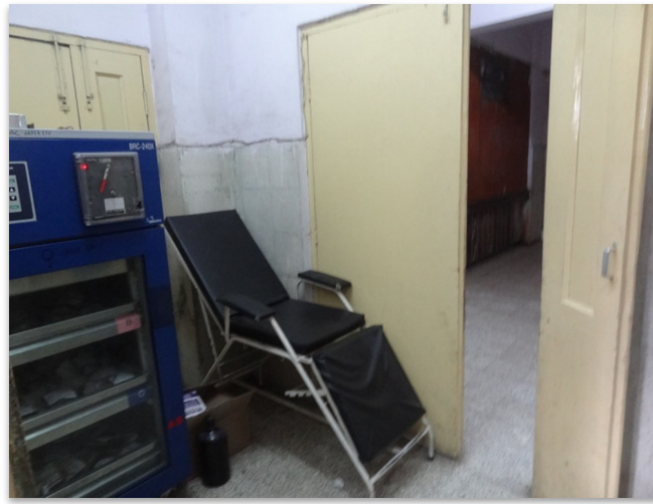
Figure 27: Wider leaf of door blocked by furniture

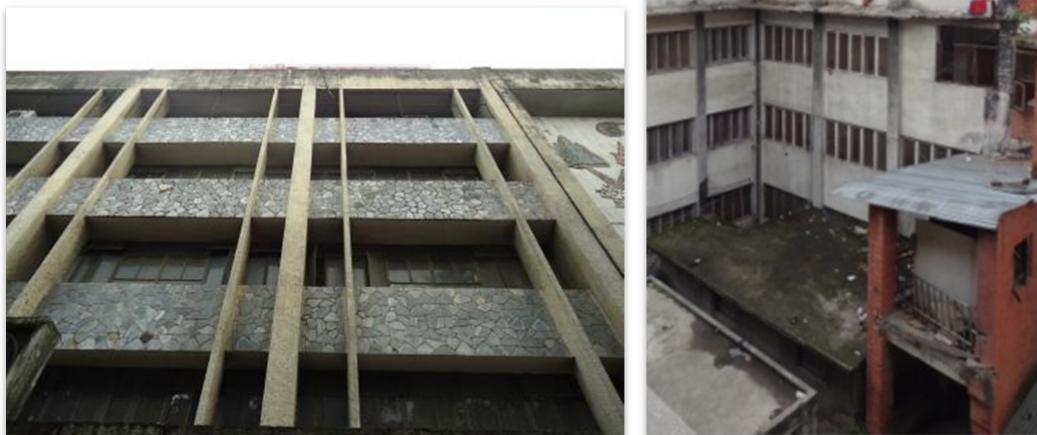
The condition of windows and shutters is poor, and window glass may shatter and hinder evacuation and egress. The thin stone cladding elements (using a kind of terrazzo in which irregular stone panels are set in the facing panels) of the external walls may fall off in moderate to severe shaking and cause injuries on the ground. This would be critical at the hospital's main access areas. The facades of some of the buildings have architectural projections, both horizontal ledges and vertical pilasters, which are not part of the structural system (Figure 28). It is not known how these are anchored to the structural system; if the connections are weak, these elements may constitute falling hazards. Falling debris would make the open air spaces between the buildings quite unsafe for pedestrians and for any post-disaster activities such as assembly or triage.

Figure 28: External cladding above the entrance (left) and horizontal and vertical projections of the building facades (right)
