Guru Tegh Bahadur Hospital

A Summary of the Seismic Evaluation and Retrofit Process

Delhi Earthquake Safety Initiative for Lifeline Buildings

December 15, 2008

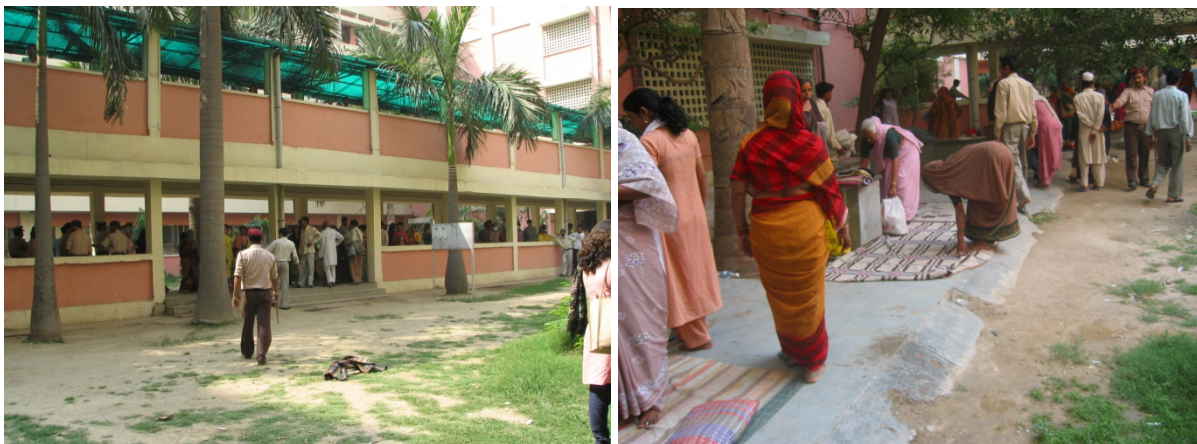
Figure 5. Two storey corridor across the central courtyard (left); courtyard occupied by relatives of patients (right)

At the time this report was written, Delhi PWD was finalizing the partition anchorage drawings, so they were not available. IIT Roorkee was developing a retrofit scheme for the two-storey corridor, which their analysis showed was likely to collapse.

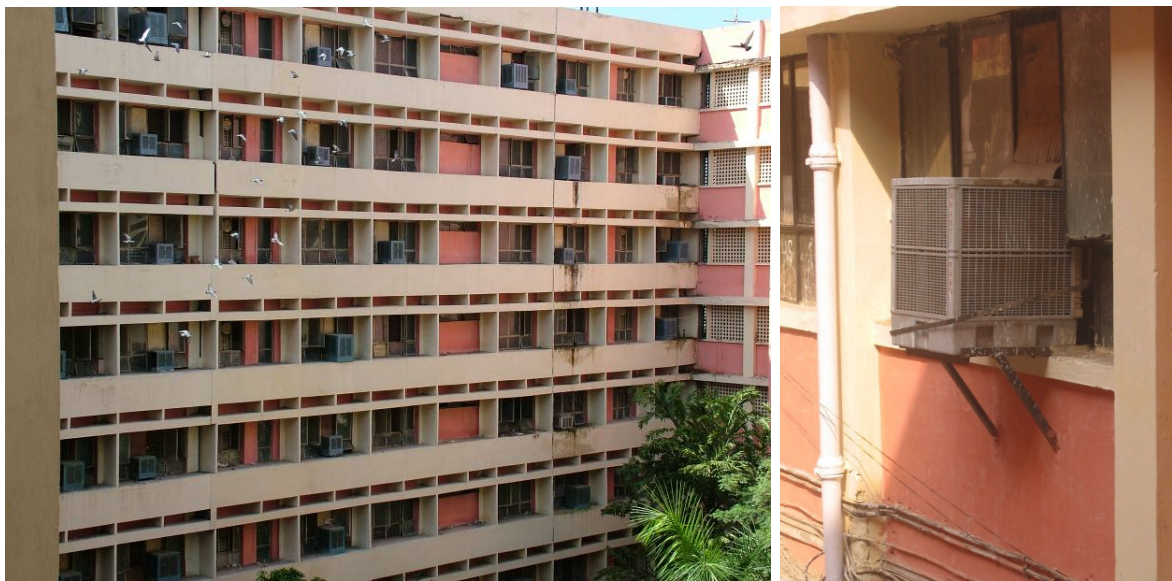
The windows have reinforced concrete sill bands spanning between each column. The sill bands project about 760 mm (30 in) and form the top of the storage cupboard for the patient rooms. The floor slab also projects 760 mm (30 in) as a cantilever and functions as the floor of the cupboard. Bricks were laid between the floor slab and sill band to form the back of the cupboard. There are also fins on all external walls, which do not have proper development length to resist any lateral forces. Figure 6 shows the cupboards, fins, and window air coolers. All of these items could fall from the building into the courtyard below during an earthquake.

Figure 6. Elevation views of interior courtyard showing fins, cupboards (wide cream-colored bands) and air coolers (left); inadequately secured air cooler (right)

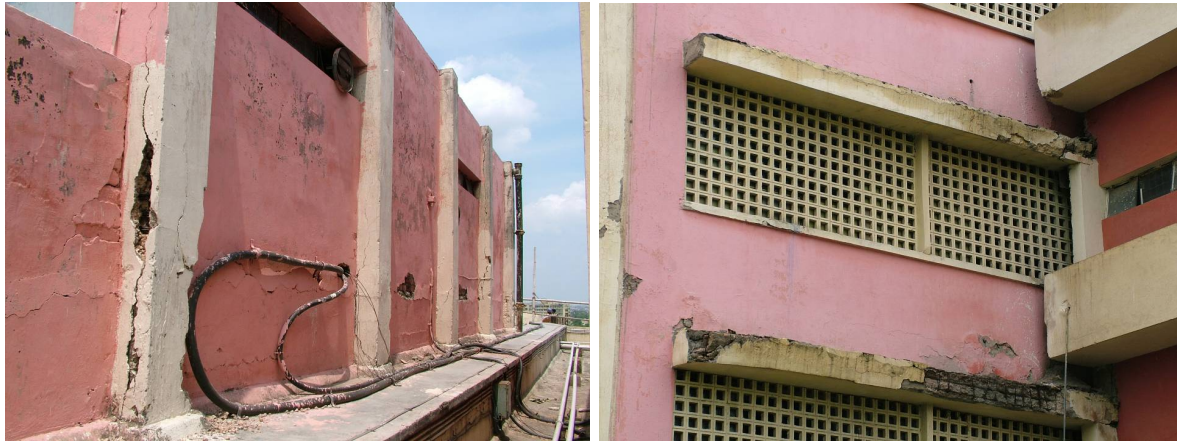
Delhi PWD conducted a condition assessment and found that there was no major visible deterioration in most of structural members such as columns, beams and slabs. However, a small number of external columns had noticeable cracks and corroded rebar. The machine room columns on the roof and some exterior architectural elements were badly deteriorated, as Figure 7 shows.

Figure 7. Corroded columns at machine room on roof (left); spalled concrete on exterior architectural elements (right)

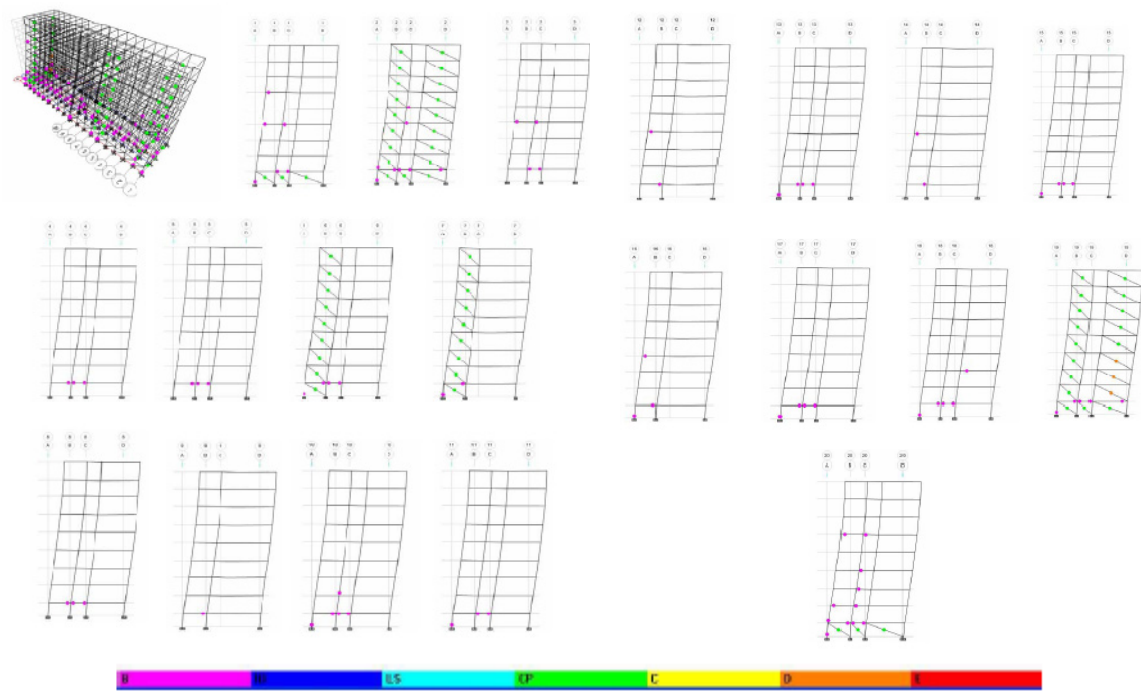
Figure 8 shows the deformation in plastic hinges at the MCE target displacement in the transverse direction, obtained by nonlinear static pushover analysis. Figure 9 shows similar results for the longitudinal direction. The legend shows how the hinge colors relate to the FEMA 356/ASCE 41 deformation limits used to determine whether the building meets the performance criteria. The only hinges not pink or blue (the colors signifying IO performance) are the diagonals that represent the brick infill walls in the model, which are green, meaning they are at collapse prevention.

Figure 8. Plastic hinges at the MCE target displacement, X-direction. Pink or blue indicate IO, green indicates CP.

The nonlinear analysis results in Figure 8 (transverse direction) and Figure 9 (longitudinal direction) showed that when the pairs of blocks were connected together, the building's frame could achieve immediate occupancy performance in both the DBE and the MCE. The infill partitions would collapse, however, and needed to be restrained against out-of-plane failure.

- Insert steel channels in each room to brace the brick partitions out-of-plane. The channels can also be used to anchor equipment and furnishings;
- Strengthen the two-storey corridor;
- Place flexible connections on rooftop pipes where they cross expansion joints;
- Anchor and brace major mechanical equipment in the physical plant;

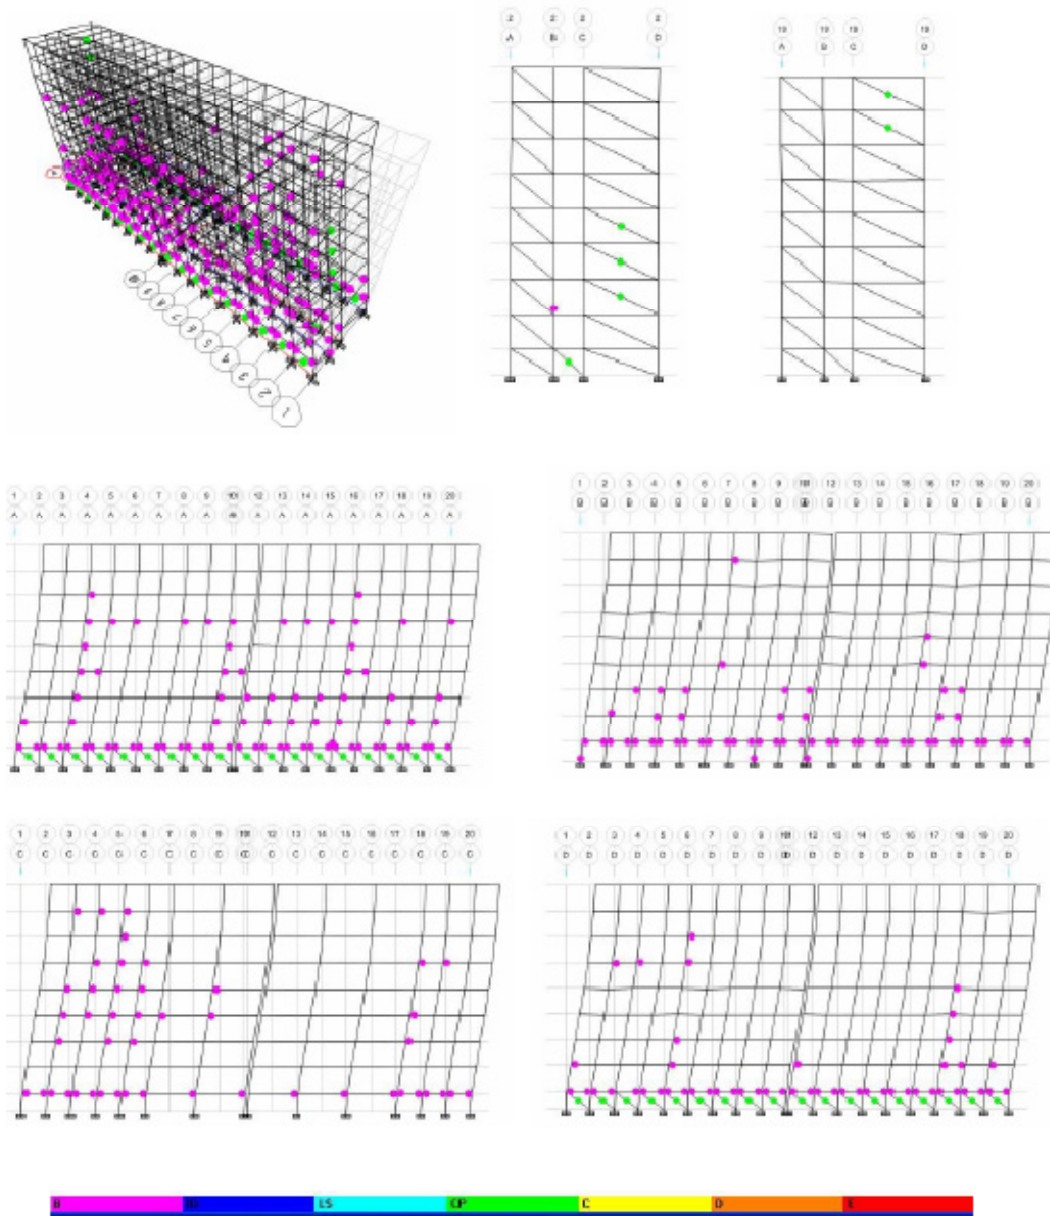
Figure 9. Plastic hinges at the MCE target displacement, Y-direction. Pink or blue indicate IO, green indicates CP.

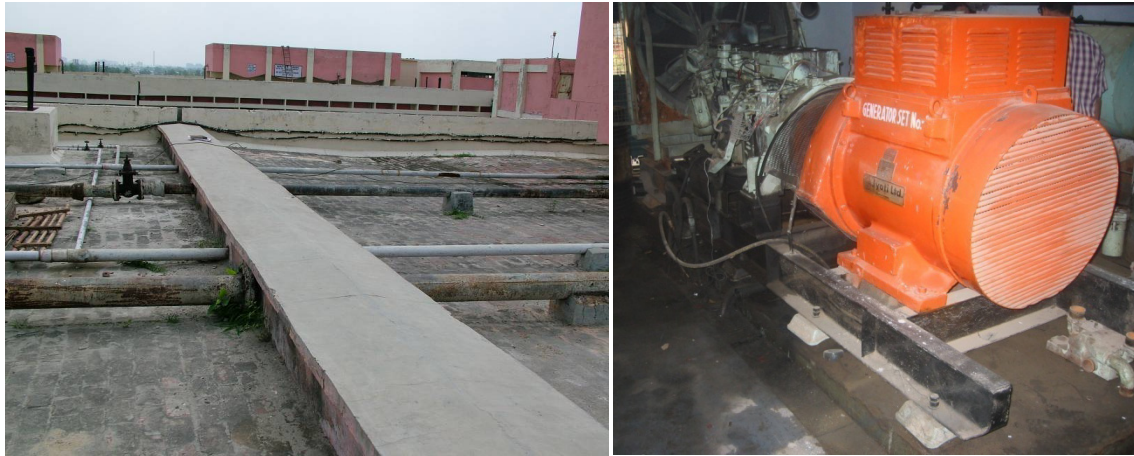
Figure 10. Rigid pipes crossing an expansion joint on the roof (left); unanchored emergency generator (right)

prepared an extensive report on these items entitled “Survey of Non-Structural Components at GTB Hospital, Delhi.” Because the ward block building and the new base-isolated building will perform well even in the largest expected earthquake, the hospital’s equipment, systems and furnishings need to be braced in advance, so that the hospital can function after an earthquake. Delhi PWD plans to anchor these items, after the structural retrofit is complete.
