Initial Seismic Vulnerability Assessment  
of Equipment, Utilities,  
Architectural Shell and Contents  
at  
Paropakar Maternity and Women's Hospital  
Thapathali, Kathmandu, Nepal

July 31, 2013

Prepared for the World Health Organization Regional Office for South-East Asia by

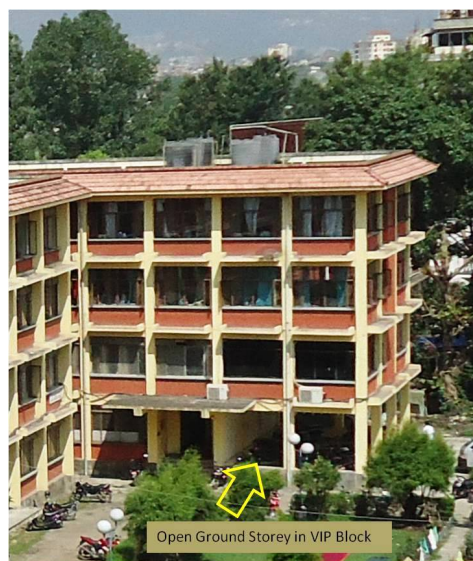
The VIP Block has a partially open ground storey to accommodate a garage in the front of the building (Figure 6). It is unlikely that seismic design considerations for open ground stories were used to design the VIP Block. Therefore, a soft-storey mechanism may occur during an earthquake, which would significantly affect the seismic performance of this building.

Figure 6: Open ground storey in the front portion of the VIP Block

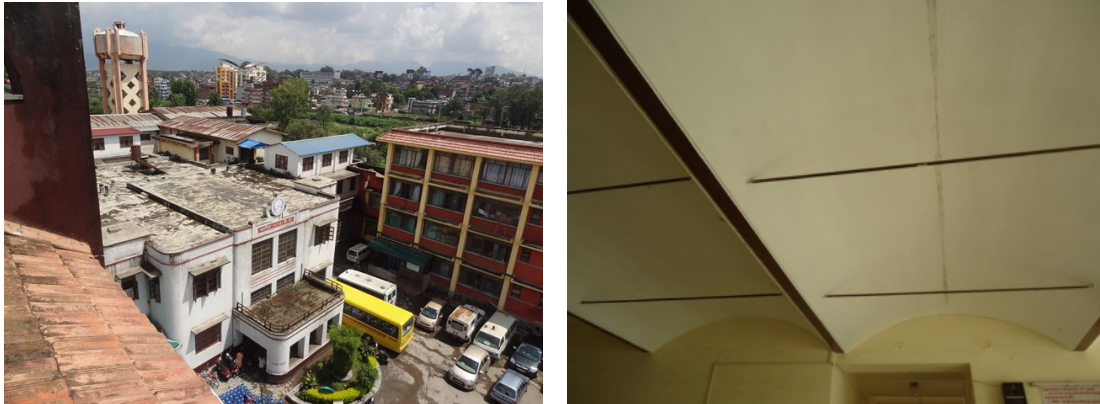
The two-storey Old Block (Figure 7) was built in 1959 with assistance from the Government of India. The building is understood to be constructed of load bearing (unreinforced) brick masonry with lime mortar. In 1959, India had no codes in place with provisions for earthquake resistant design of load bearing masonry buildings. The floors are constructed with jack arches which can be vulnerable to earthquake-induced lateral forces. The tie rods in the jack arch floors appear to be rusted and in poor condition in many locations.

Figure 7: View of the Old Block (left); jack arch roof in Old Block (right);

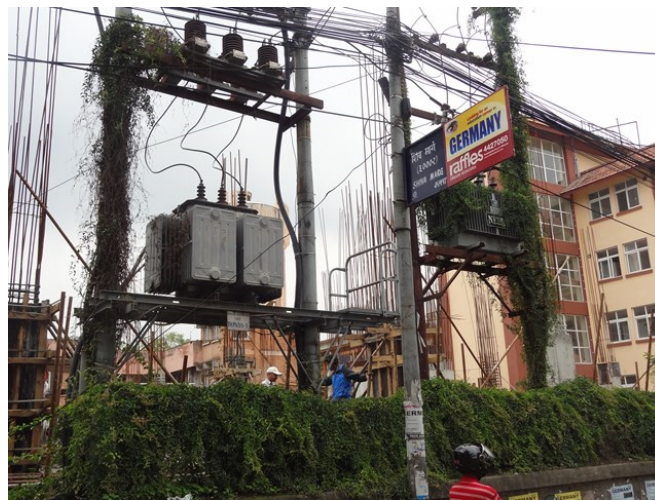
Figure 8: The two transformers

The hospital has two transformers of 250 kVA capacity each. These transformers that receive the HT power supply are placed on a pair of poles adjoining the boundary wall (Figure 8). These are prone to toppling in earthquake shaking and need to be braced. Even if grid power returns, the hospital may not be able to access it due to damage to the transformers. During the critical response period immediately following the earthquake, the hospital may be dependent on backup power.

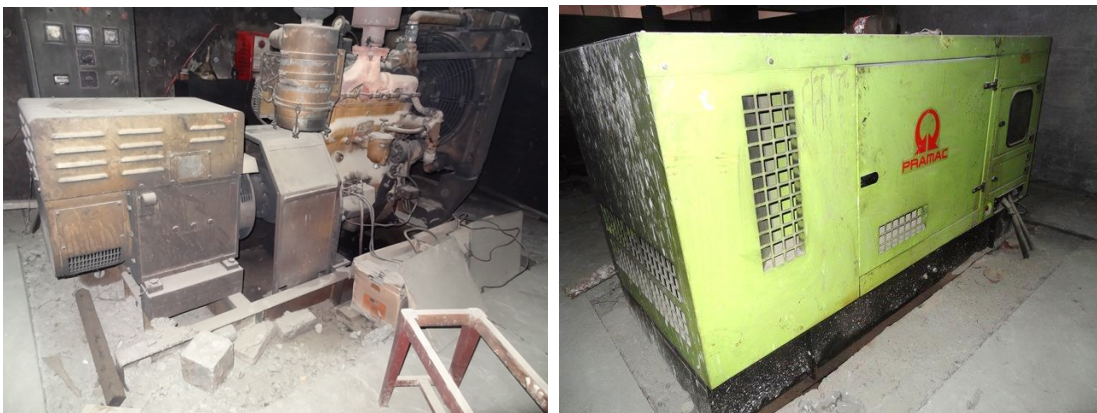
The evaluation team observed multiple vulnerabilities in the backup electrical power system, which is likely to cause failure of the backup system in a strong earthquake and possibly in a moderate earthquake, leaving the hospital completely without power. Both generators are placed on sunken floors with uneven and unfinished surfaces. They have a few bolts fixing them to the floor. However, the number and spacing of the bolts and their inadequate connections to the uneven floor add to the possibility of their being dislodged in moderate earthquake shaking (Figure 11).

There is no exhaust system in place, nor are there any muffling elements. There has been an attempt to anchor some of the ancillary systems such as the fuel tank and electrical cabinets (Figure 12) through fabricated steel anchors. However, safety practices seemed to be lacking: the battery charger and the power connection to it are placed on top of the fuel tank, which could lead to a fire in case of any short circuit in these wires (Figure 13). The tank also lacks flexible piping, and supply of generator fuel would be affected if the rigid pipes break during earthquake shaking. The manual generator has batteries abutting the generator. The batteries are located on corner supports and not on a continuous platform. They are not bolted to the floor, nor are they braced or restrained to prevent lateral movement.

Figure 11: Manual generator (left); automatic start generator (right)

Both the generators and the electrical backup supply system need to be seismically protected so that they will not come off their supports, and so that the power supply remains uninterrupted. The additional generator available in the campus should also be commissioned to provide robustness to the backup supply and must have facilities to enable automatic switchover to backup facilities when the main grid fails.

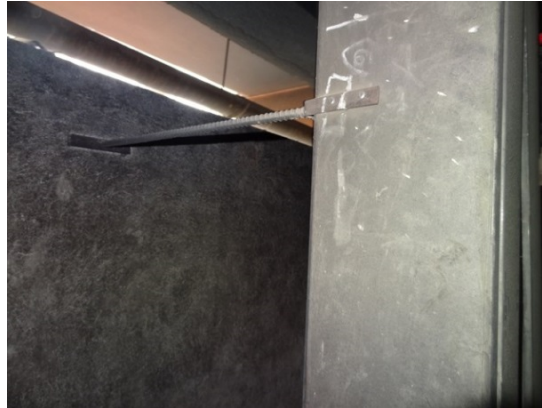
Figure 12: Fabricated anchorage for electric switchbox

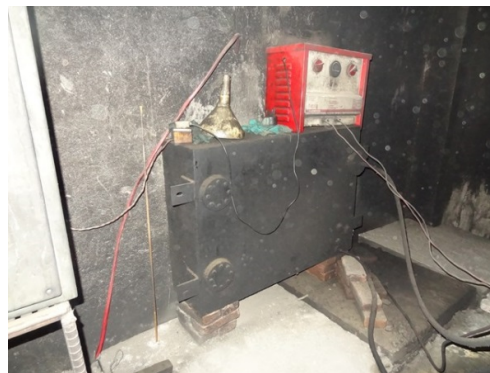
Figure 13: Battery Charger and power plug placed over the diesel tank

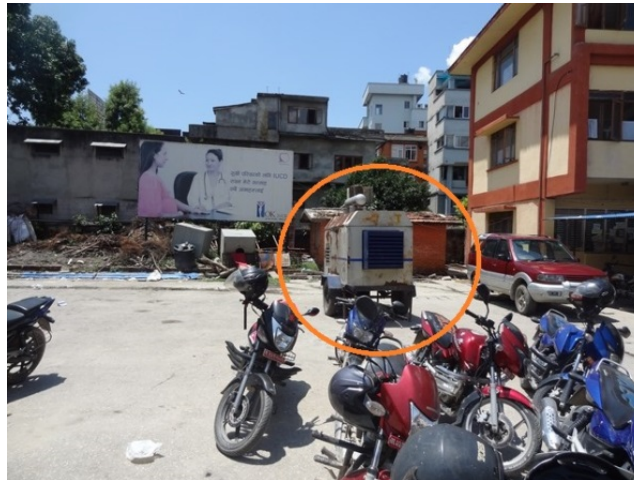
The hospital has procured one additional generator, but it has not yet to be commissioned and is presently stored in the parking lot (Figure 14).

Figure 14: Third generator not yet functioning, stored unused in parking lot

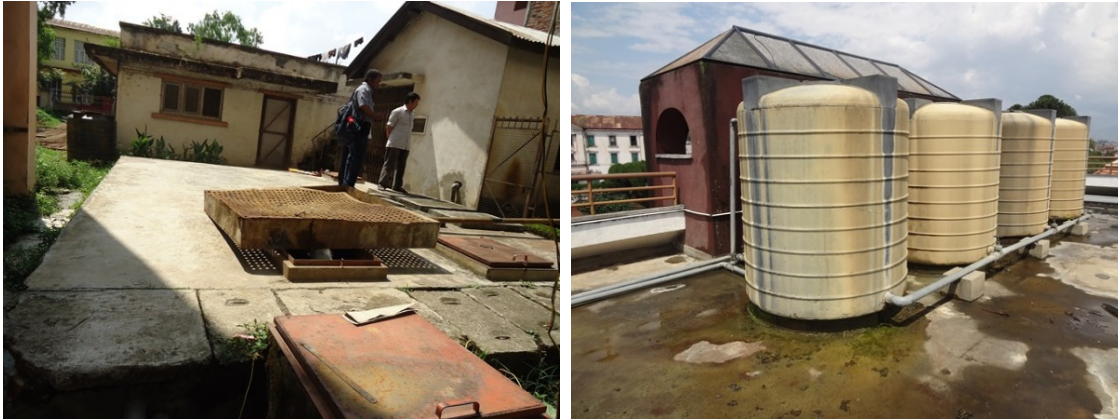
Water storage tanks for untreated water are located in secure locations but there are no measures for their protection against damage from shaking. Evaluation of the seismic resistance of the ground level reinforced concrete water tank (Figure 15) was outside the scope of this assessment, but it is possible that the tank, the unreinforced masonry pump house, or the pipes connecting the tank to the hospital could be damaged and cause leakages. None of the inlet and outlet pipes have flexible connections, and the rigid connections could be damaged in earthquake shaking.

Figure 15: Underground water storage tank (left); Rigid pipes connecting roof top water tanks (right)

Overhead (rooftop) tanks need anchoring to prevent sliding or toppling in moderate to severe earthquake shaking. Water treatment equipment needs to be anchored to prevent damage that would disable the treatment system. Replace rigid connections to the Tower Tank and overhead water tanks and to filtering/ water treatment equipment with flexible connections, to accommodate differential movement and prevent breaks that could drain the tanks. Water supply lines crossing building joints should have flexible connections at the joints sufficient to accommodate the expected amount of differential displacement. The fire suppression system needs to be repaired.

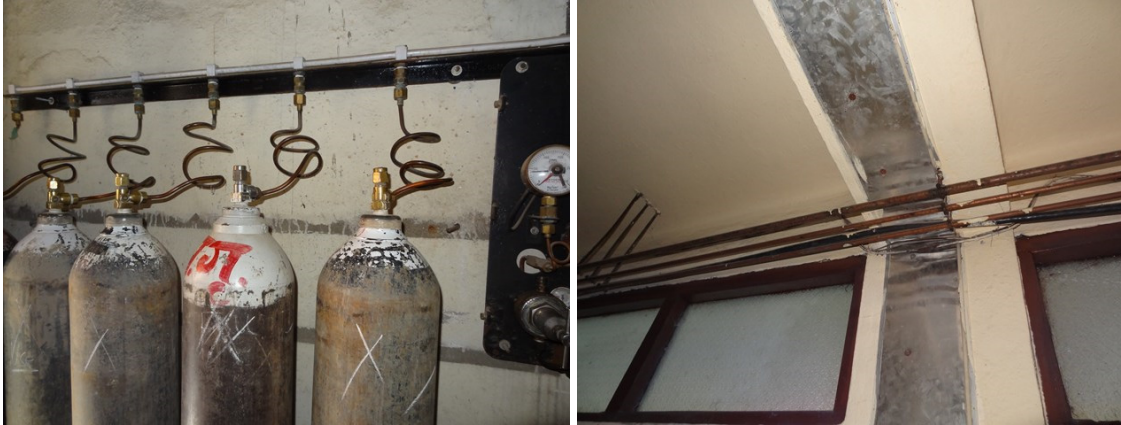
The oxygen bank uses a manifold with 15 unanchored cylinders that are connected to it by semi-flexible copper tubing (Figure 16 ). During an earthquake, a number of cylinders will topple, disconnect from the manifolds, and possibly leak, leading to a possible fire and explosion hazard. The hospital stores 50 to 60 cylinders of oxygen cylinders of 680L and 8 cylinders of 130L. While the piping is secure, there is no flexibility where the lines cross expansion joints and into a different building (Figure 16). This may cause damage during shaking. The medical gas storage facility is accessible, and the cylinders and related equipment are fairly well protected in exclusive storage areas operated by trained personnel. However, the storage area is an unreinforced masonry building

that may suffer earthquake damage that would disrupt the oxygen supply system. Oxygen and other medical gas cylinders are not restrained in any of the storage locations in the hospital.

Figure 16: Oxygen cylinders and semi flexible copper tubing (left); rigid oxygen lines cross expansion joints in the New Ward Block (right)

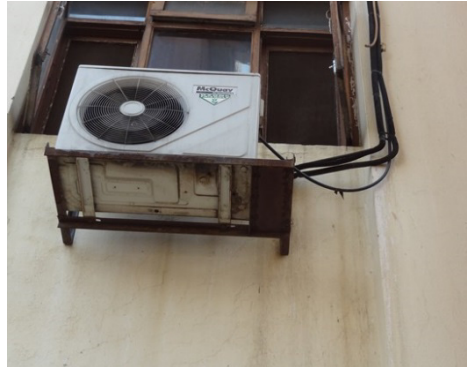
While the hospital does not have a central HVAC system or boilers, the buildings do have numerous small air conditioning units. A number of these units sit unanchored on narrow exterior façade ledges or steel cages, where they can fall during shaking and kill or injure those below (Figure 17).

Figure 17: Air conditioning split unit placed dangerously on building exterior

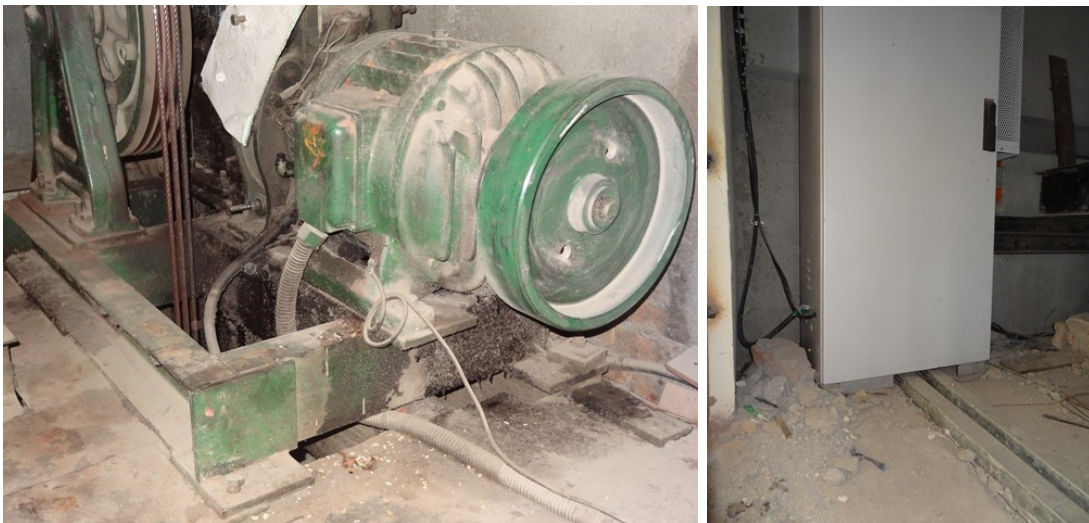
The hospital has two lifts, located in the New Ward Block and the New Block, neither of which is operational during generator power supply. The evaluation team assumes that the lift in the New Ward Block was not designed for earthquake forces, because there are no seismic provisions for lifts in the Indian Standard codes, and the buildings were constructed prior to development of the Nepal National Building Code. The lift rails and counterweights are vulnerable to earthquake damage. During strong shaking, the counterweights can derail and crash through the top of the lift car. It should be noted that lift machinery is located at the top of buildings, where shaking tends to be strongest, because the building amplifies earthquake motions (Figure 18).

Figure 18: Machine room of old lift (left); Unanchored electric box of new lift (right)

The earthquake safety of the lifts (especially the lift in the New Ward Block should be ascertained by a qualified structural engineer, and corrective actions should be taken if found necessary. The electric panel in the new lift should also be restrained to prevent damage in any earthquake shaking.

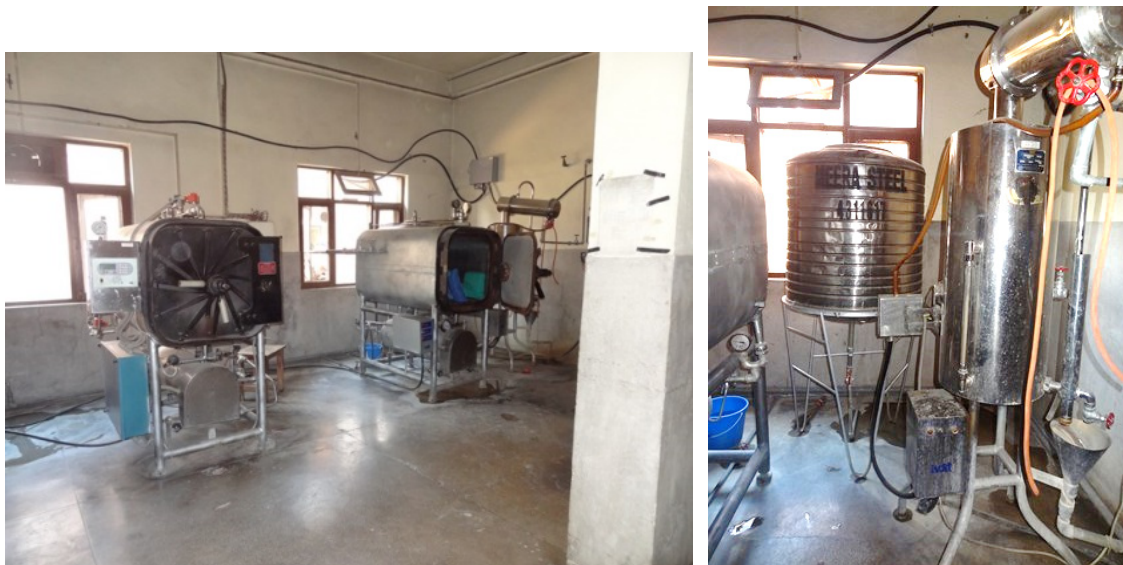
The Central Sterile Supplies Department (CSSD) is a critical facility for any hospital, as all sterilisation occurs there. None of the autoclaves (Figure 19) have been anchored to withstand earthquake shaking and could topple, putting the CSSD out of service which could lead to non-functionality of the Operation Theatres. Autoclaves also have small distilled water tanks (Figure 19) attached to them, which are placed on unstable stands vulnerable to toppling even at low levels of shaking. The water pipes connected to the autoclaves all have rigid connections, which could lead to breakages and leakages and will likely affect the functioning of the CSSD in any earthquake.

Figure 19: Autoclaves (left); unanchored water tank for autoclaves (right)

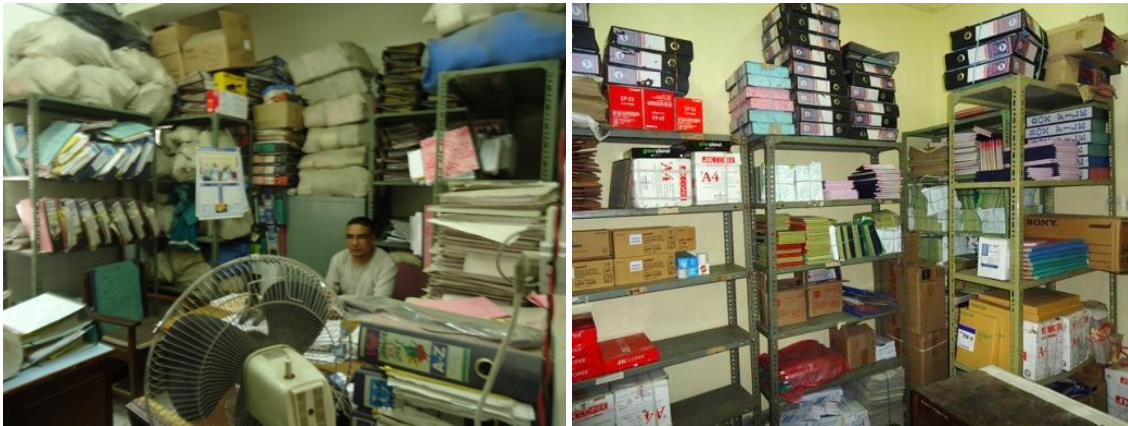
In all the treatment and diagnostic facilities surveyed, the work tables, computer tables, laboratory shelving, and storage units are not adequately secured or fastened for protection against lateral shaking (Figure 20). Moreover, in numerous locations, tall shelves full of glass contents are placed next to exit doors. They will likely topple in an earthquake, spilling their contents, and broken glass and liquid on important evacuation routes (Figure 20).

Figure 20: Officer sitting among dangerous falling hazards (left); unanchored cupboards and shelves with more loose objects placed above (right)

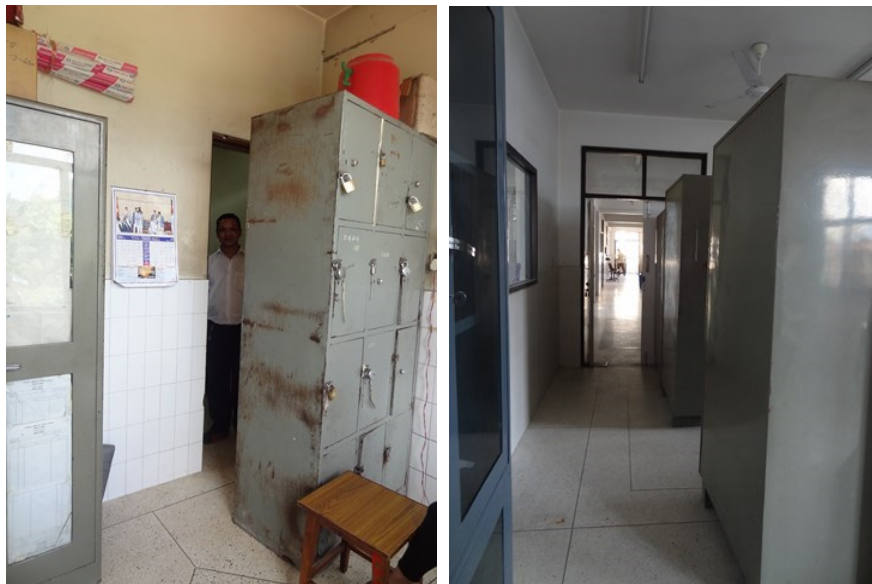
In many spaces, especially in nurses' rooms and certain wards, tall cupboards are used as partitions and could pose a threat, in terms of injuries and loss of exits, to room occupants. Many corridors are lined with cupboards and lockers that not only reduce the width of exit pathways, but will also fall down during earthquake shaking and block the exit path (Figure 20). Many wards have glass partitions that are likely to shatter during shaking, causing injuries and impeding egress (Figure 22).

Figure 21: Blocked exit of Nurses' Room (left) and corridors with reduced effective width due to furniture placement (right)

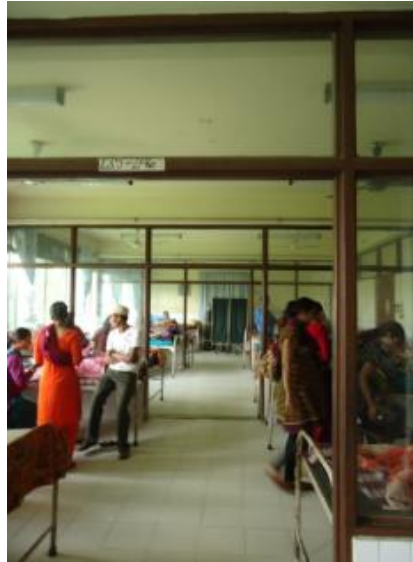
Figure 22: Glass partition walls in wards

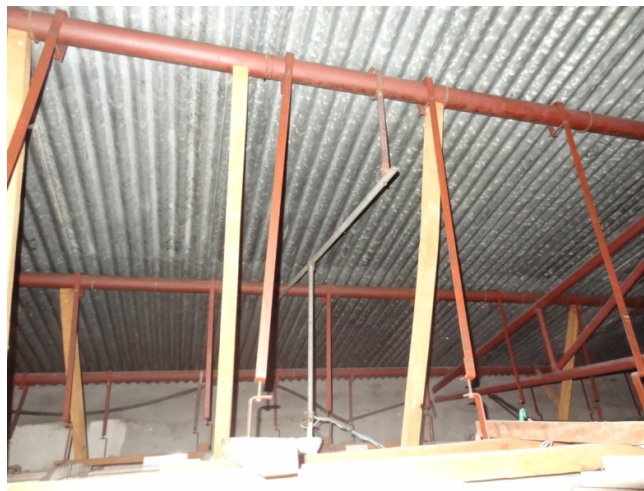
Suspended ceiling in some of the functional areas in the Old Block are made of acoustical tiles placed on a timber framework, which in turn is hooked to a corrugated galvanized iron (CGI) roof (Figure 23). The CGI sloped roof does not have positive connections with the walls and would act like a flexible diaphragm in earthquake shaking. As a consequence, both the roof and the suspended ceiling would likely suffer damage.

Figure 23: Suspended ceiling over parts of the Old Block.

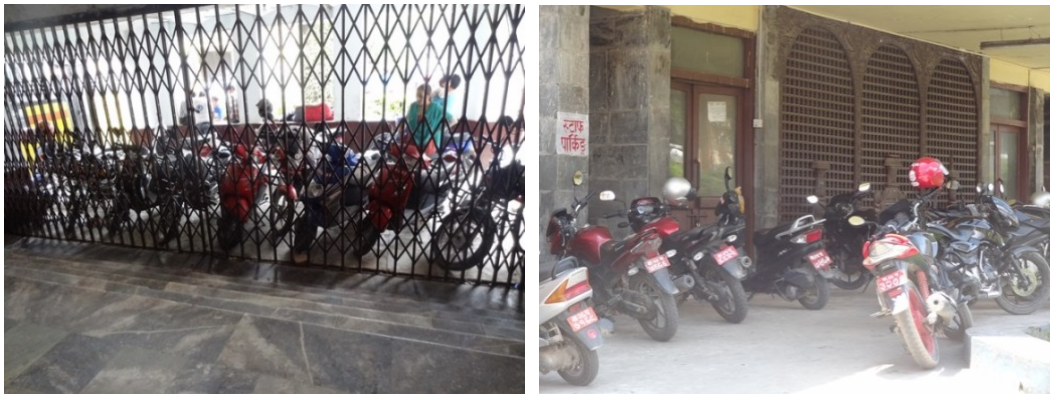
As mentioned above, many of the corridors have been partially blocked by cupboards, racks, and lockers. However, the most critical aspect is that the main exits of the New Ward Block and the Old Block (Figure 24) are locked, and the space in front is used for the parking of staff two-wheelers. This means that a person at the New Ward Block would have to walk through the Old Block and exit the building through a corridor in the Emergency Block. This presents a very dangerous and potentially life threatening scenario, as every occupant from every floor in the New Ward Block, the Old Block and the Emergency Block would have to use a single exit. For occupants of the New Ward Block, the travel would also be through a circuitous route that would be difficult to negotiate in an emergency.

Figure 24 Main exit of Old Block locked (left); and main exit of New Block blocked
