# Delhi Secretariat (Dilli Sachivalaya)

## *A Summary of the Seismic Evaluation and Retrofit Process*

### *Delhi Earthquake Safety Initiative for Lifeline Buildings*

**December 15, 2008**

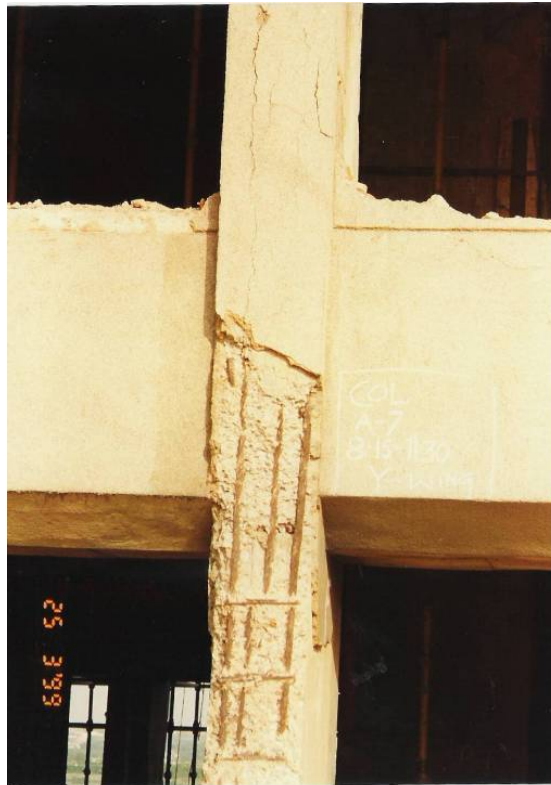
**Figure 5. Column before rehabilitation showing tie spacing and deterioration**

Because of the recent building rehabilitation, Delhi PWD did not conduct independent condition assessments but instead, relied on information obtained during the rehabilitation. The rehabilitation

process restored the building to close to its original strength. Unfortunately, the original construction and material quality were fair to poor. The concrete had relatively low strength.
