The Quito,

Ecuador

School Earthquake

Safety Project

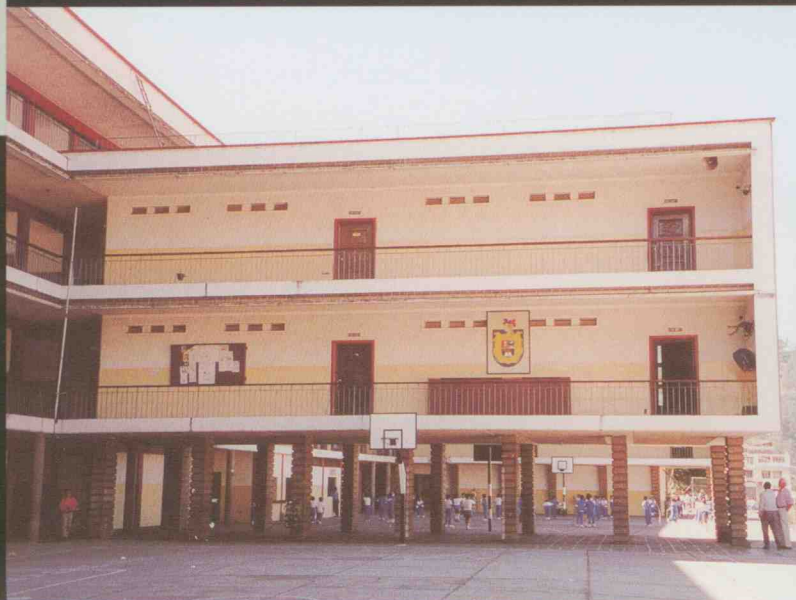
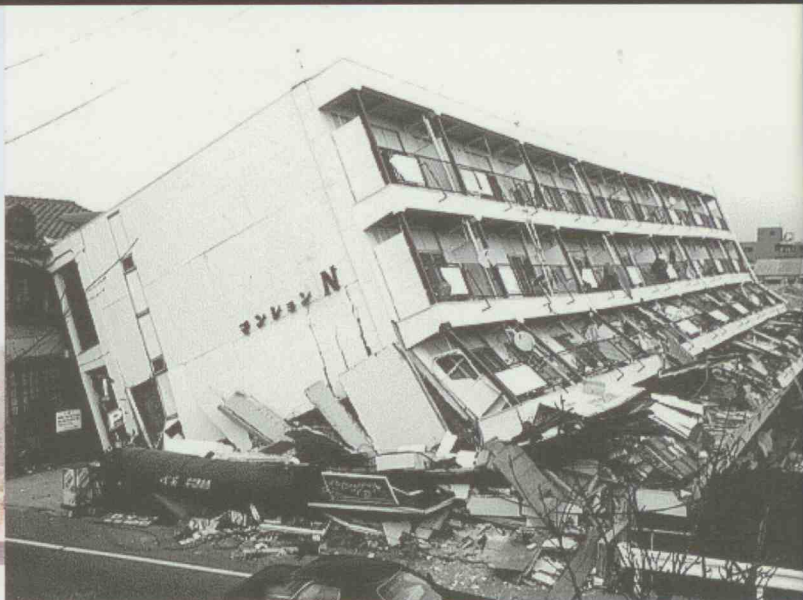
"SOFT" FIRST STORY

Two common structural deficiencies are “soft” stories (such as stories without infill walls) and “short” columns (columns effectively shortened by partial infill walls). Shown are examples of each in Quito schools, and an earthquake-damaged building that had a “soft” first story.

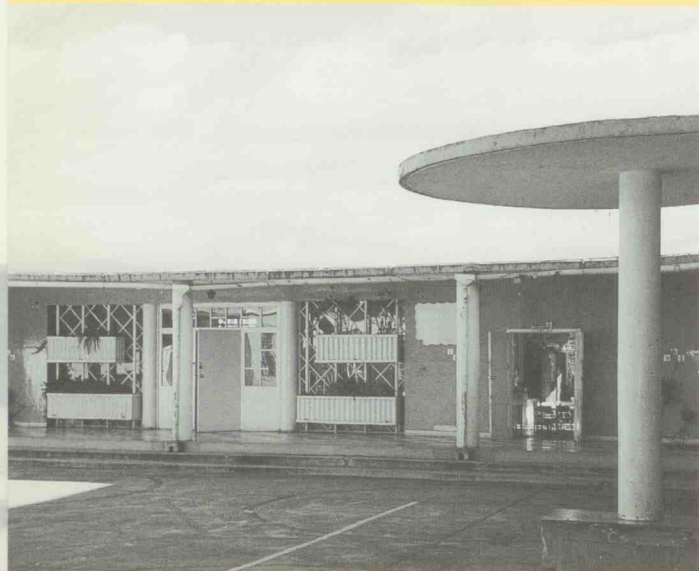
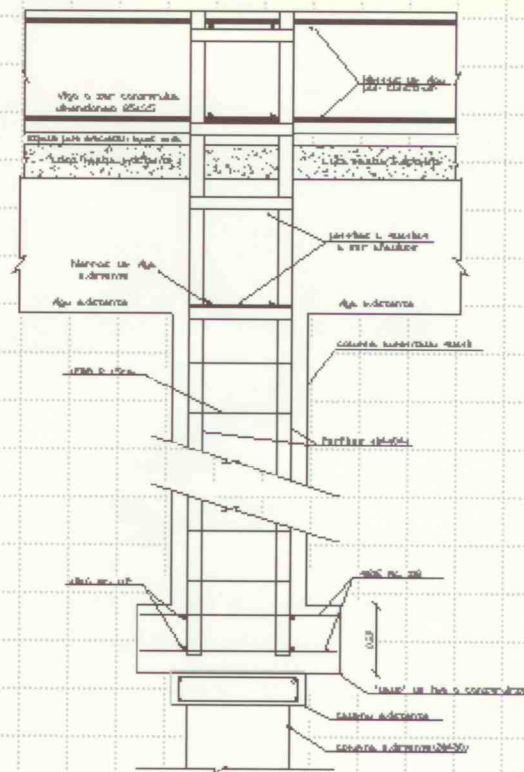
Detail of Column and Roof Slab

Weak concrete beams and columns put the structure's frame at risk of collapse during a major earthquake. Several columns are lacking sufficient reinforcing steel, and most beam-column joints are inadequate. The concrete roof slab is deflecting excessively in several places; cracks in the slab allow rainwater to leak into the building.

The building will be strengthened by adding reinforced concrete beams above the roof slab and steel columns, and by strengthening the existing reinforced concrete columns and beam-column joints. This would create lateral-load-resisting frames for the building, increasing its ductility during earthquakes, diminishing stress on its structural elements, and halting the deflection of the roof slab. The roof will be sealed with a watertight coating.

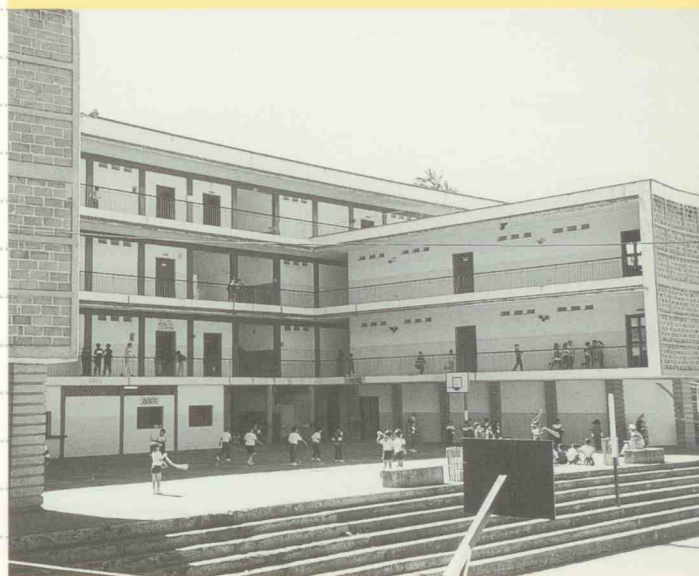
Experimental Sucre's beams and columns are not sufficiently strong to provide earthquake resistance to their structures. Door and window openings have created short columns. The first story of each transverse block lacks infill walls, creating a soft-story condition. The transverse buildings will likely pound against the main building during an earthquake.

Shear walls will be added to the buildings in both the longitudinal and transverse directions. Two options have been proposed for constructing the shear walls. The first consists of adding reinforced masonry walls to the first floor (transverse buildings only) and replacing the walls of upper floors with properly connected reinforced masonry ones. The second design consists of adding unreinforced masonry walls to the first floor (transverse buildings only), and surface strengthening them and upper-floor walls with steel mesh and concrete. Shear walls will increase the stiffness of the portal frames and thereby mitigate soft-story and pounding hazards. Separation joints will be added between walls and columns to mitigate short-column hazards.

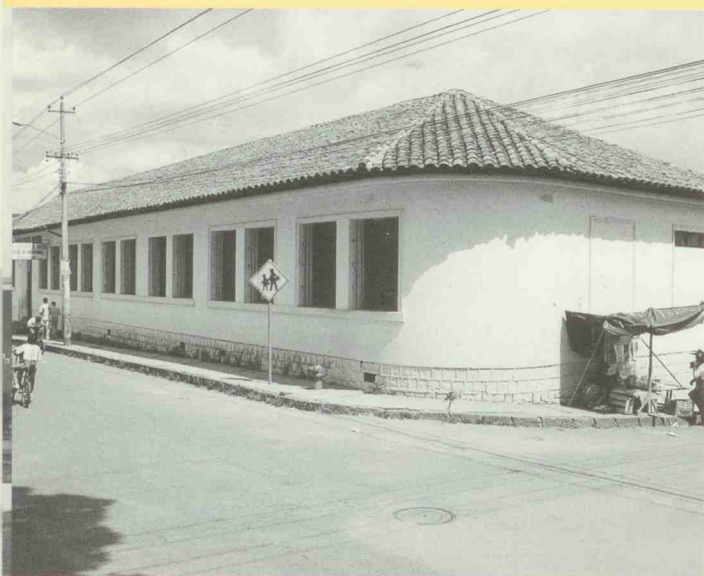
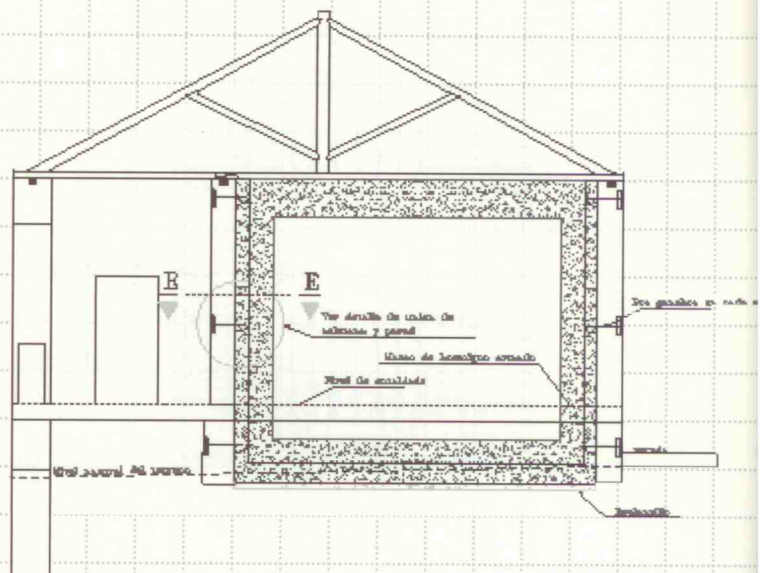
Retrofit Design Detail

The two major problems with this building are a weakness in its transverse direction and the hazardous roof. The longitudinal walls have long, unbraced spans between transverse walls. The extreme length of the spans makes them dangerously flexible in the out-of-plane direction.

The wood roof trusses are splitting in places. The truss joints and connections to the walls are not sufficient to transfer earthquake loads. The roof lacks bracing in the longitudinal direction. These deficiencies could cause the roof structure and overlying tiles to collapse into the classrooms below during an earthquake. The roof tiles, held in place by gravity alone, could slide off the roof in an earthquake and onto the playground and sidewalk below.

Two options were suggested to reinforce the structure along its transverse axis. The first consists of building in the transverse direction a 40-cm-thick, continuous unreinforced masonry wall, confined by a reinforced concrete beam and columns. This would divide a large, multiple-use classroom. The second, a less invasive design, is to construct two reinforced concrete frames in the transverse direction of the building.

The roof trusses will be repaired and their joints and connections strengthened, and cross-bracing will be added in the plane of the roof. The roof tiles will be anchored to prevent them from moving in an earthquake.

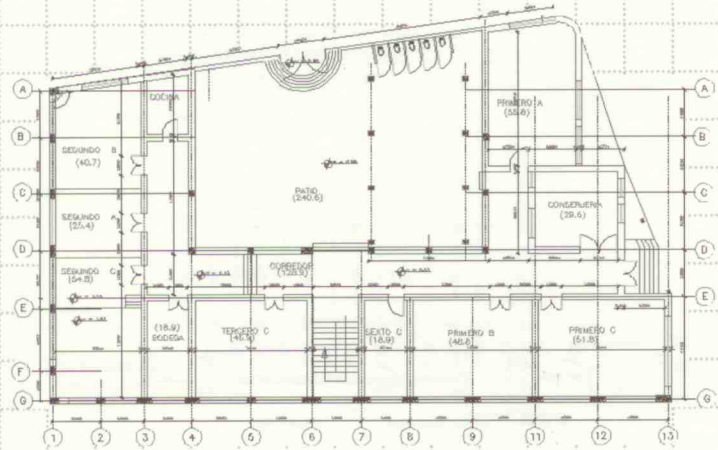
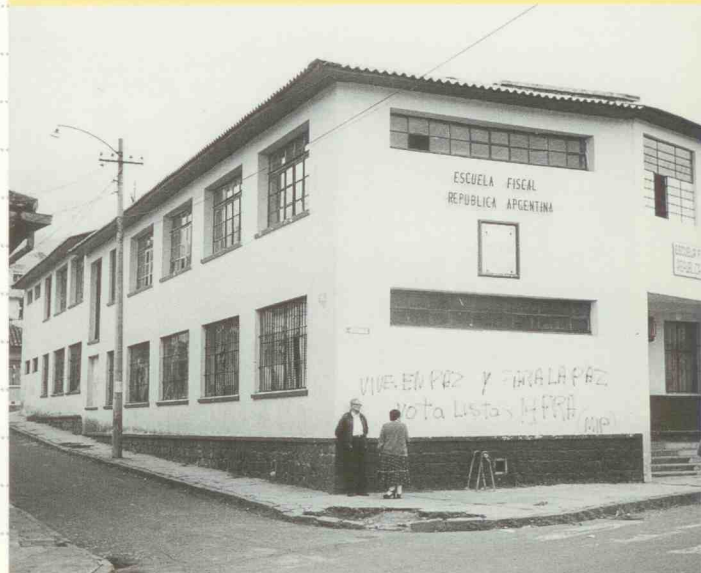
Building Plan

The interior and exterior unreinforced masonry bearing walls have openings that create, in effect, a hazardous short-column condition. The beam-wall connections are deficient. Since the wood beams and roof structure are supported by the walls, failure of the beam-wall connections during an earthquake would result in building collapse.

The wall openings will be modified to reduce the short-column effect. Better connections will be provided between intersecting walls. The in-plane rigidity of the floor and roof systems, as well as the connections with the supporting walls, will be improved.

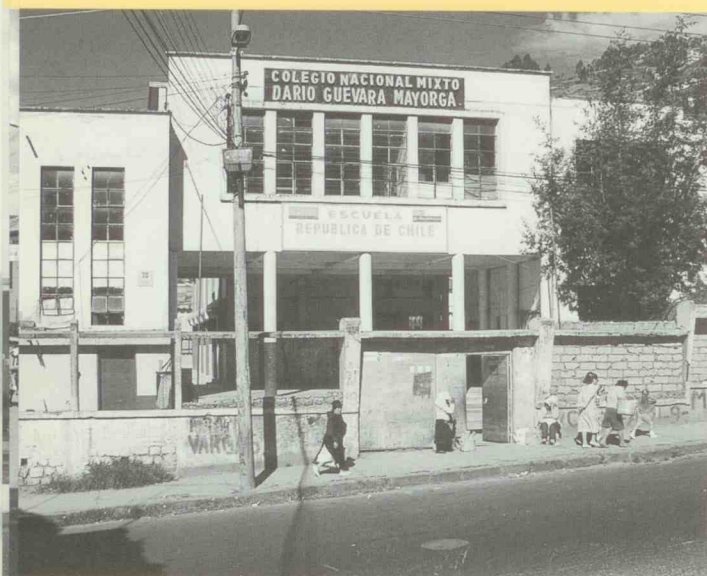
Retrofit Design Detail

The slab reinforcement and the reinforced concrete columns have deteriorated from exposure to water. In some areas the concrete contains soft aggregate or construction debris. The buildings contain short-column hazards, and the weak infill walls will likely crack and collapse during a strong earthquake. These buildings are not able to resist strong or long-duration earthquakes. Many ceilings contain unanchored clay tiles, which could fall during an earthquake.

The columns of Blocks 1, 2, and 3 contain smooth reinforcing steel. Slender cylindrical columns on the ground floor of Block 2 are not aligned with the corresponding columns on the second floor, resulting in a discontinuity between the columns and beams. Many beam spans are unusually long, and the beam distribution is inefficient. Block 4 lacks structural frames in the longitudinal direction, substantially diminishing the structure's ability to resist earthquake forces.

Because the República de Chile school was built without an earthquake-resistant structural system, the frames of Blocks 1, 3, and 4 will be completely redesigned. Due to the extremely poor design and condition of Block 2, it will be demolished and rebuilt. The ceiling tiles in all classrooms will be removed and replaced with lightweight, secured panels.

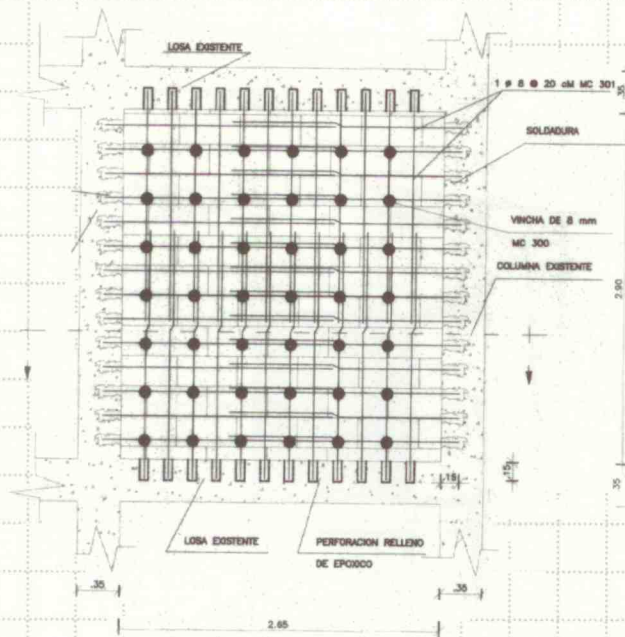
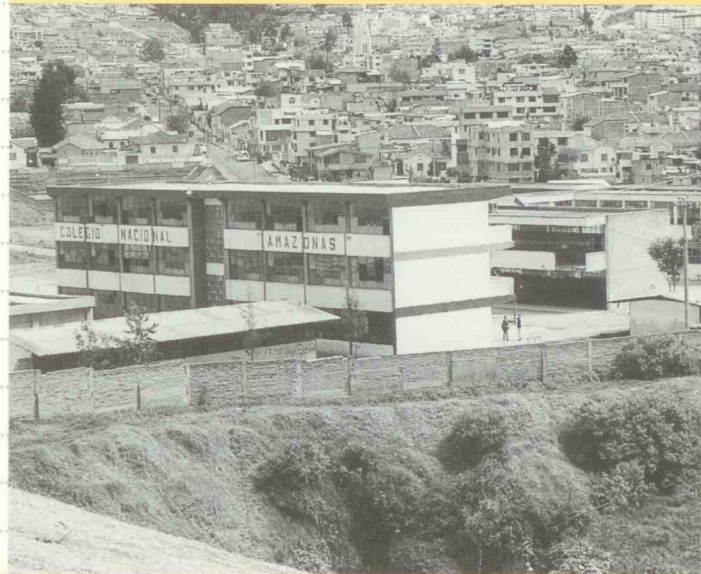
Retrofit Design Detail

The original building designs did not consider lateral forces. Inadequately connected portal frames in the longitudinal direction do not provide sufficient stiffness or strength to transfer properly lateral loads during an earthquake. Construction joint separations are too small and could permit pounding during an earthquake. Window and door openings and mid-height partition walls create short-column conditions. The staircase modules show excessive deflection.

Additional structural elements will be added to the buildings in order to increase their longitudinal stiffness. Two options are recommended: strengthening the unreinforced masonry infill walls by replacing them with reinforced masonry walls with proper connections to the concrete frames, or surface strengthening the existing walls with steel mesh and reinforced concrete. Separation joints will be added between walls and columns to mitigate short-column hazards. Supporting elements will be added to control deflection of the staircase modules.

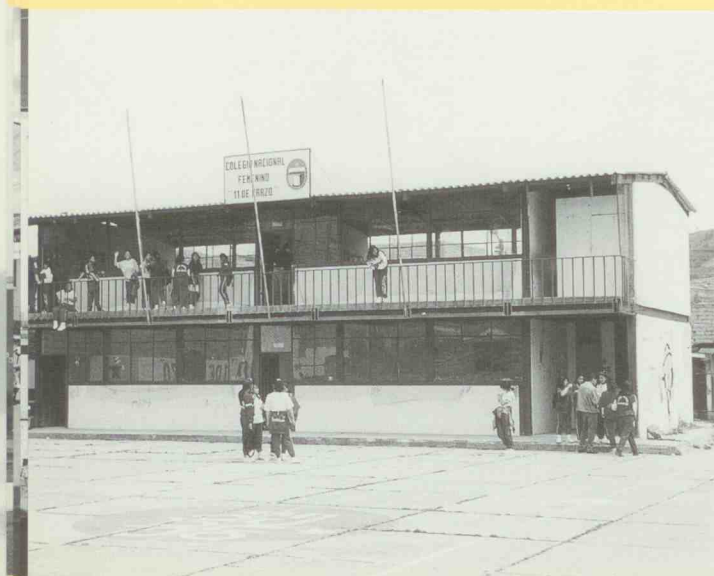
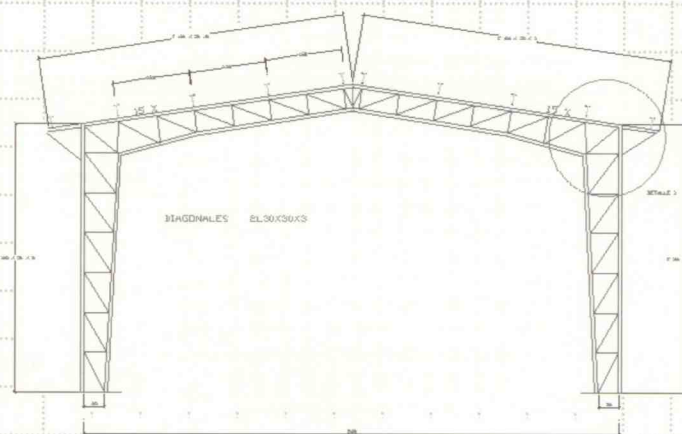
Retrofit Design Detail

Because the unreinforced masonry infill walls are much stiffer than the steel frames, the wall-frame interaction could result in major damage to the frame during strong ground shaking. The bending capacity of the first-floor beams is low, and the beam-column connections in the longitudinal frames are not sufficiently rigid, potentially resulting in sudden collapse of the structure during an earthquake. Several steel members are corroded.

Separation joints will be added between walls and columns. The bending capacity of the first-floor beams will be increased with proper reinforcement. Beam-column joints of the longitudinal frames will be reinforced to ensure continuity and proper frame action. Corrosion problems will be mitigated, and exposed steel members will be painted to prevent further corrosion.

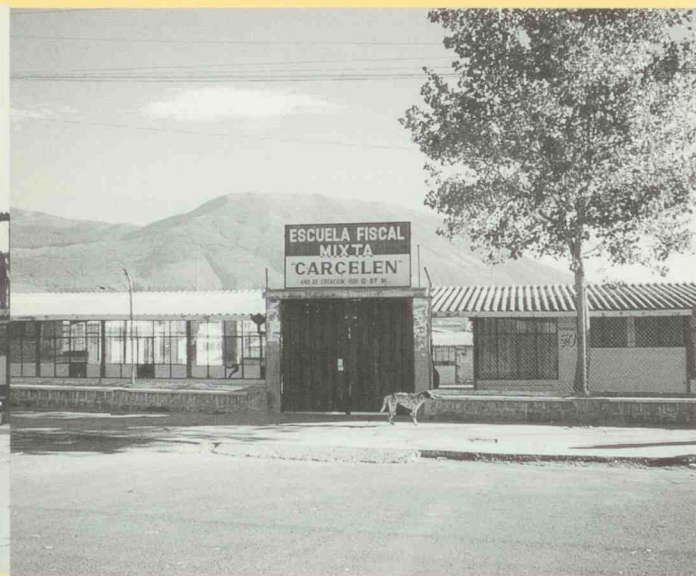
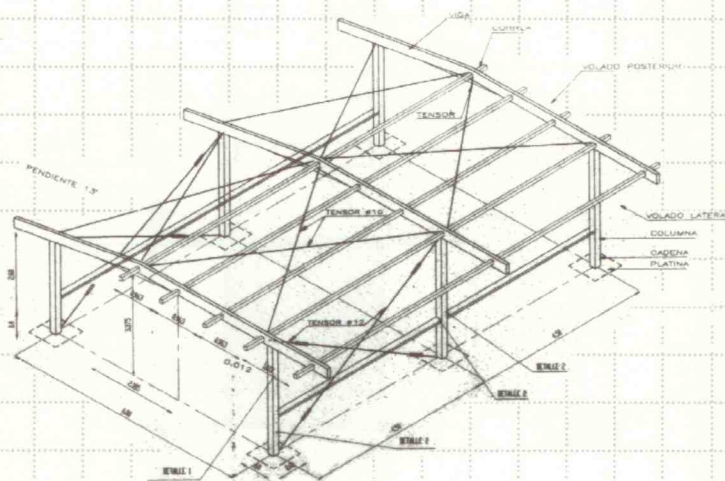
Retrofit Design Detail

The rigid, unreinforced masonry infill walls are much stiffer than are their flexible steel frames; the interaction of forces between the walls and frame could result in major damage to the frame during strong ground shaking. Window and door openings in the longitudinal walls create hazardous short columns. Corrosion of some steel members has reduced their strength and consequently their ability to resist earthquake loads. Modules are frequently altered after construction, sometimes creating additional hazards.

Retrofit solutions for the most common deficiencies were developed. In general, the retrofit designs call for adding horizontal tensors at the roof level to increase earthquake resistance in the longitudinal direction; adding 2-cm joints between walls and columns to mitigate short-column effects; and mitigating the effects of corrosion by filling the tubular columns with concrete, and painting all steel members.

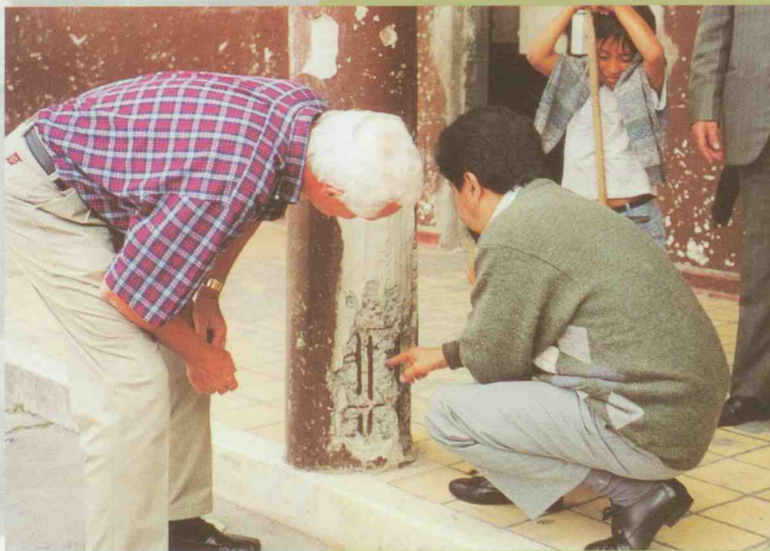
Engineers are shown here inspecting the República de Chile school, one for which retrofit funds have been committed.
