Initial Seismic Vulnerability Assessment
of Equipment, Utilities,
Architectural Shell and Contents
at
Kanti Children's Hospital, Kathmandu, Nepal

July 31, 2013

Prepared for the World Health Organization Regional Office for South-East Asia by

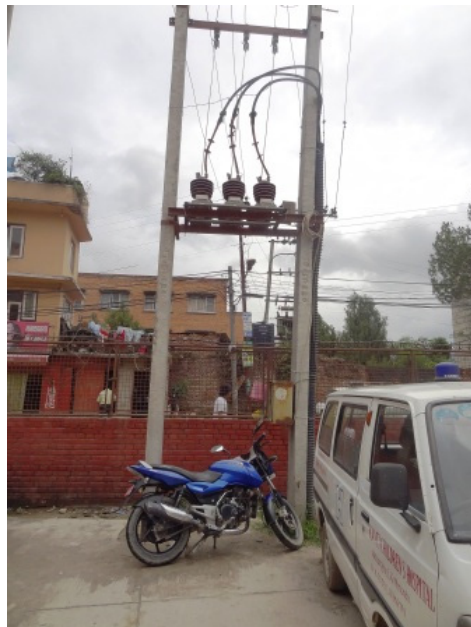
Figure 5: 11kV HT Feeder line supply point

The hospital's electric power supply comes from the local grid. The 11kV high tension (HT) feeder line from the Nepal Electricity Authority (NEA) comes to a substation located right in front of the Emergency Block (Figure 5). A single step-down transformer of 750kVA capacity supplies 400V electrical power to the hospital through Low Tension (LT) panels. The transformer is bolted to the floor (Figure 6).

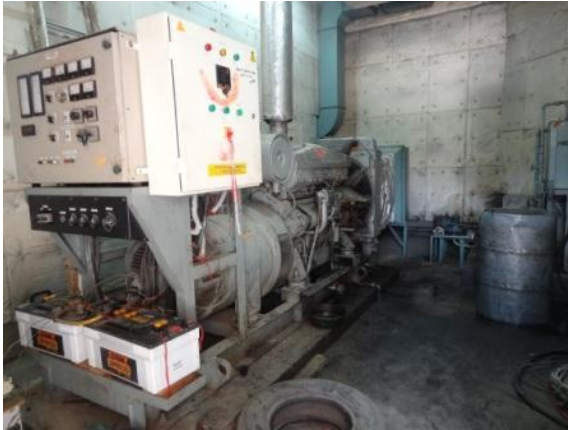
Figure 7: Generator bolted to the floor

The generator is bolted to the floor and is unlikely to be dislodged in moderate earthquake shaking (Figure 7). The day fuel tank is also anchored and braced (Figure 8). Calculations, which are outside the scope of this report, would be necessary to determine whether the anchorage systems for the generator and day tank have adequate capacity to meet the expected seismic demands. The batteries for the generator rest on racks that are bolted to the floor. However, the current set of batteries seems to be larger than the rack, hence the batteries have been placed on a set of bricks inside the rack (Figure 9). These batteries are likely to slide off from the racks in spite of the presence of a continuous guard piece. The exhaust system is vertically supported but is not laterally braced against earthquake forces (Figure 10), and as a result could be damaged by shaking, potentially rendering the generator inoperable.

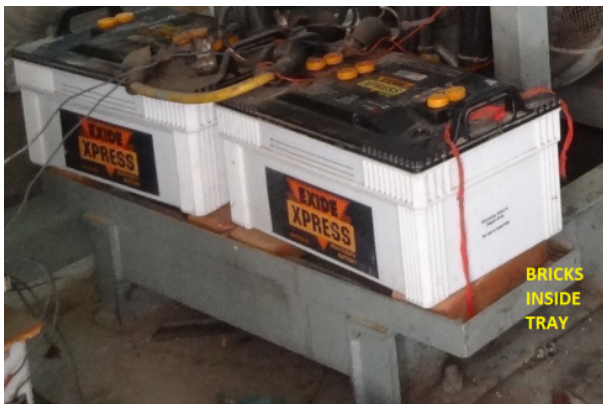
Figure 9: Batteries placed on bricks in the battery tray may slide off in earthquake shaking

The Kanti Children's Hospital has a backup power system that automatically starts when the grid supply fails, and has some seismic protection measures in place. However, the backup system still has some significant vulnerabilities, and the distribution system to the older parts of the hospital can be disturbed in an earthquake, as older buildings and their utilities have not been designed for earthquake safety. The fuel storage capacity is not utilized fully, and only a fraction of the 6000L capacity is available at any time on site. GHI recommends that the hospital utilize the tank's currently unused capacity to store enough fuel for the PAHO-recommended five days or the estimated length of time to restore grid power, whichever is longer. Also, since the hospital rarely suffers extended power outages, and the maximum outage has been for 12 hours with an early warning, it is important that the hospital plan for extended runs as may be required in an emergency. The allocation of the Repair and Maintenance Services (RAMS) staff for generator maintenance for extended runs must be incorporated in the preparedness plan for the hospital. While the backup power system is partially seismically protected, GHI recommends that the hospital install seismic protection for the batteries and generator exhaust, and verify, via engineering calculations, the adequacy of existing protection measures for the expected level of shaking.

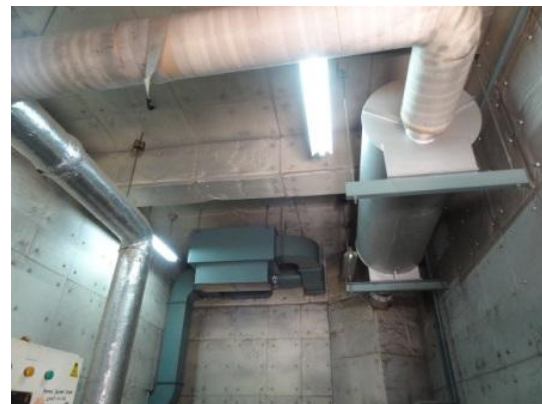
Figure 10: generator exhaust and muffler system anchored vertically only

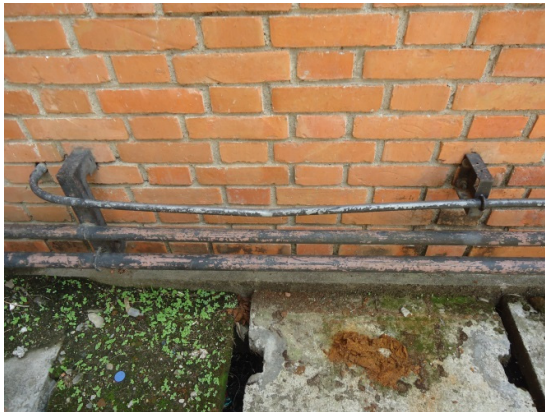
Figure 11: Inlet pipes of generator fuel anchored to external wall

The inlet piping from the underground fuel tank is anchored on the external wall of the building (Figure 11). However, both the fuel tank and the supply lines for fuel from the underground fuel storage tank lack flexible piping (Figure 12). The supply of generator fuel would be affected if these rigid lines were to break during earthquake shaking.

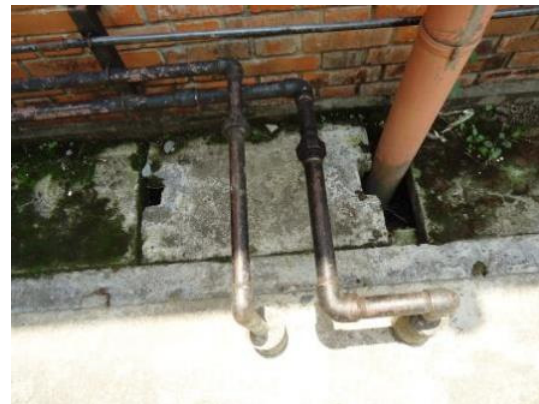
Figure 12: Lack of flexible piping in generator fuel supply lines

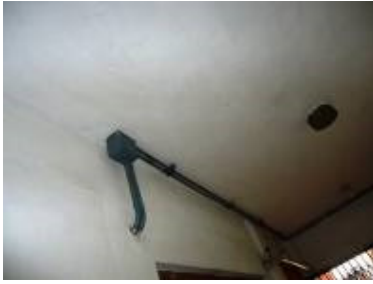
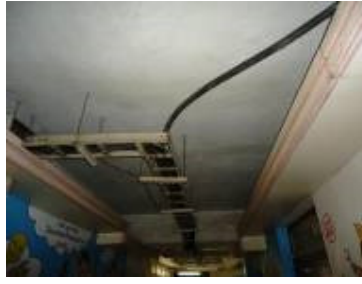
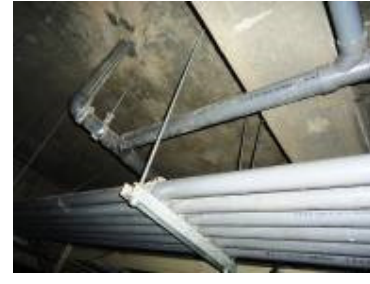
The electrical distribution system appeared well organized with individual conduits bolted to the wall and cables in trays (Figure 13 - Figure 15). The electrical conduits are clamped to the walls at regular intervals to prevent slippage during shaking. There did not appear to be flexible connections across joints between buildings, and the distribution system could be damaged by differential building movement in these locations. Cable trays are hung from the ceiling and not laterally braced, but this is unlikely to cause significant damage.

Figure 13: Electrical conduits clamped to walls

Figure 14: Trays for electrical cable layout

Figure 15: Hangers for cable trays

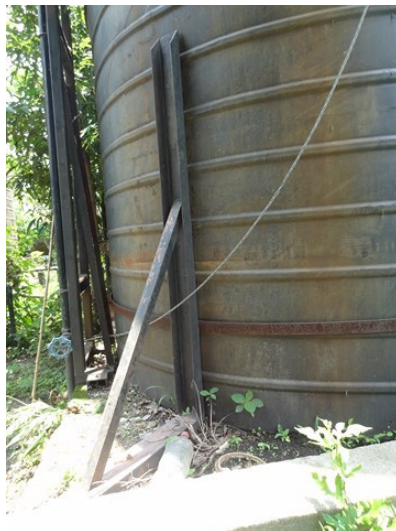
Water storage tanks for untreated water are located on the ground and are anchored by four diagonally placed supports (Figure 16) which will prevent displacement in moderate shaking. However, in higher earthquake shaking and under full storage conditions, the anchors could damage the tanks, as they go up only to about one-third of the height of the tall water tanks (Figure 17). All water pipes, water tanks and equipment installed during the construction of the Emergency (Surgical) Block and the Medical Ward Block buildings have anchorage to prevent sliding, toppling or differential movements during earthquake shaking. A solar-powered water heating system has been installed on both the roofs for supplying hot water to the Nurses' Stations, Patients Cabins, Burn Ward, and ICU. A tower tank with a storage capacity of 100,000L was built, but has not been commissioned; as the automatic cut-off systems in the roof top tanks have not been installed yet. Most of the rooftop water tanks are of fibre and have been anchored by bolts to the roof slab. However, the rigid inlet and outlet pipes may break during earthquake shaking and cause leakages.

Figure 16: Anchored water storage tanks

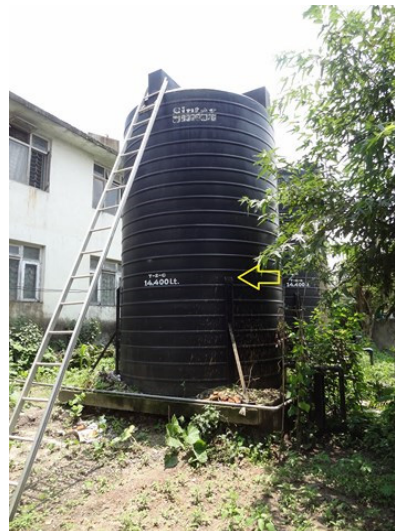
Figure 17: Anchors reach only to about one third the height of the tanks as shown by the yellow arrow

A tower overhead tank, which will provide adequate water backup for the hospital, must be commissioned at the earliest. The roof overhead tanks, though anchored, should be given flexible connections at the water inlet and outlet, to prevent breakage and leakage in any lateral shaking. The new water tanks need to be anchored to the roof slabs (a few are already anchored, others are not), and the adequacy of the anchorage for existing tanks should be verified. Water supply lines crossing building joints should have flexible connections to accommodate differential movements.

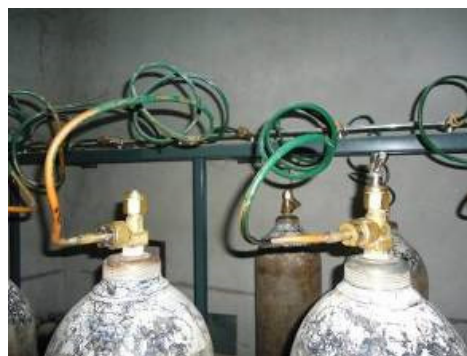
Figure 18: Flexible tubing connecting the cylinders with manifold

Piped oxygen is provided to the OTs and critical areas such as Neonatal Intensive Care Unit (NICU), Postoperative Intensive Care Unit (PICU), and Surgical Intensive Care Unit (SICU) through a manifold that is fed by 11 cylinders. The cylinders are unrestrained and are connected to the manifold by semi-flexible copper tubing (Figure 18). These cylinders are expected to topple during earthquake shaking and disconnect from the manifolds (Figure 19 left). The oxygen cylinders have the provision for additional restraints, however these have not been put in place (Figure 19 right). The hospital stores 90 to 100 cylinders of oxygen, each with 680L capacity, in various places. The cylinders stored within the oxygen supply room are accessible, and the cylinders and related equipment are well protected in exclusive storage areas operated by trained personnel. However, oxygen cylinders are not restrained in any of the storage locations in the hospital, and in many locations these cylinders will fall down in earthquake shaking and hamper egress (Figure 20). This is discussed in more detail in the section on Egress.

In addition to the reserve of 90-100 cylinders, the hospital procures 35 cylinders daily. This three-day-plus supply is significantly less than the PAHO-recommended 15 day supply for medical oxygen. However, the hospital may be able to readily obtain additional medical gas supplies, since the supply outlet is located within Kathmandu. However, the hospital's emergency plan should account for the possibility that the supplier's facilities may be damaged, and that roads between the hospital and the supplier may be blocked with debris from collapsed buildings. (Assessment of the medical gas supplier's facility was outside the scope of this assessment.)

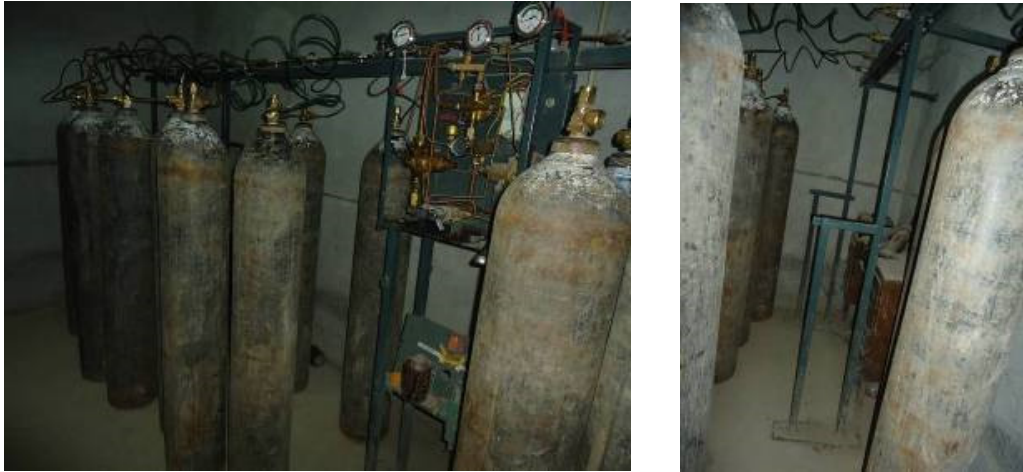
possible interruption in medical gas supply, the hospital maintains a permanent reserve of 90-100 cylinders at all times. The manifold system has provision for adequate restraining of inline cylinders through chains, but the chains are not being used. Distribution system for medical gases seems seismically adequate. The following sections present utility system vulnerabilities that were observed by the evaluation team.

Figure 19: Oxygen manifold with unrestrained oxygen cylinders (left); provision for restraining the oxygen cylinders not put to use (right).

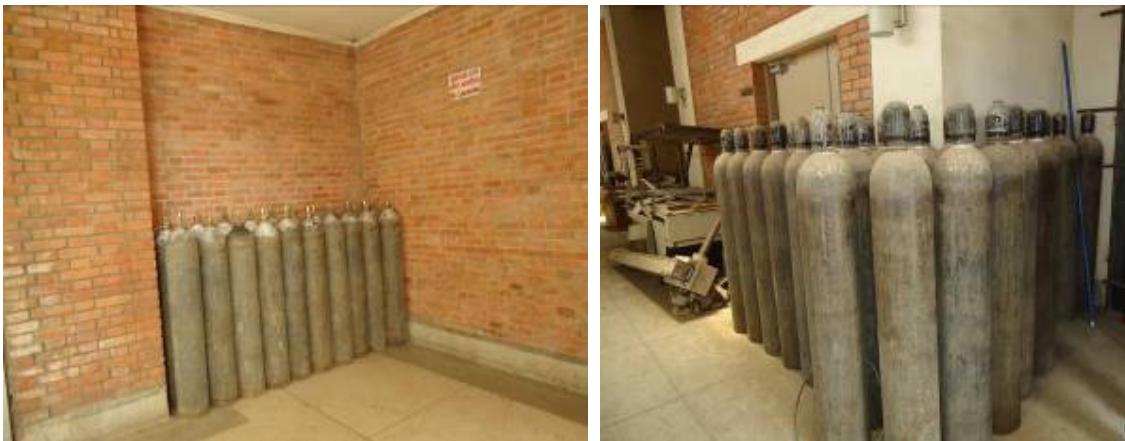
Figure 20: Oxygen cylinders stored in circulation areas (left) and at the lift lobby in the top floor of the Emergency Block (right)

smooth exit when toppled by earthquake shaking. The reserve oxygen cylinders stored outside several wards and in corridors are all unrestrained, and will fall and cause rolling hazards and block exits during earthquake shaking.

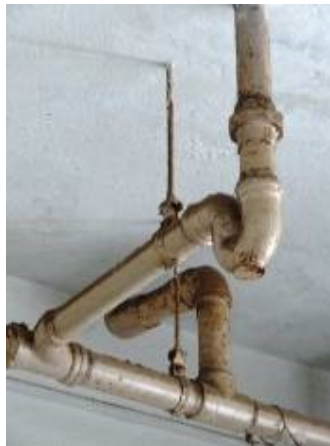
The evaluation team observed that wastewater pipes have solid vertical supports via hangers from the slab, but are not laterally braced (Figure 21). Waste piping typically uses weak and flexible connections between sections of piping and is vulnerable to damage. During shaking, these pipes could swing, become damaged and leak, creating infection control problems.

Figure 21: Wastewater pipes not laterally braced

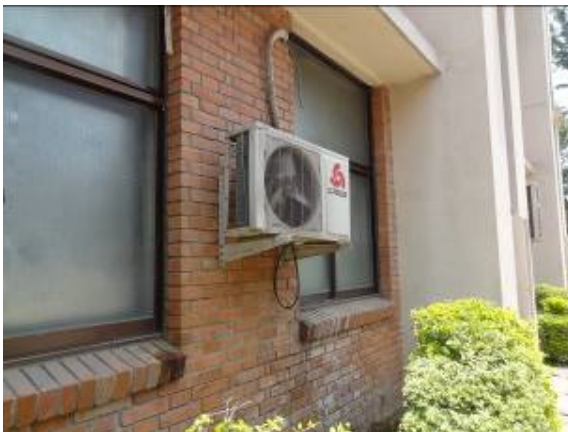
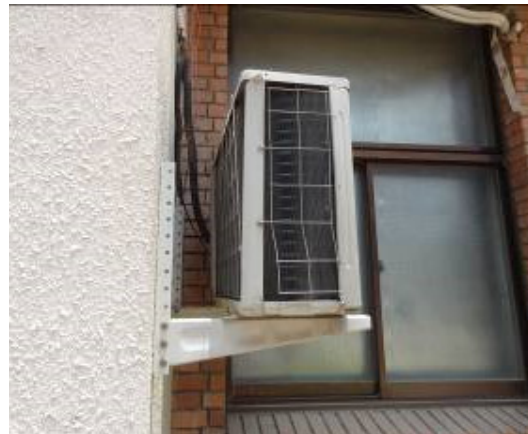
While the hospital does not have a central HVAC system or boilers, the buildings do have numerous small air conditioning units. A number of these units are placed unanchored on narrow exterior façade ledges or steel cages; these can fall during strong shaking and kill or injure those below (Figure 22 shows a typical support arrangement). The OTs have a central air conditioning system, with heating and cooling of 15T capacity. The ICUs have split air conditioning units with heating and cooling functions.

Figure 22: AC unit showing typical supports from which units can easily topple

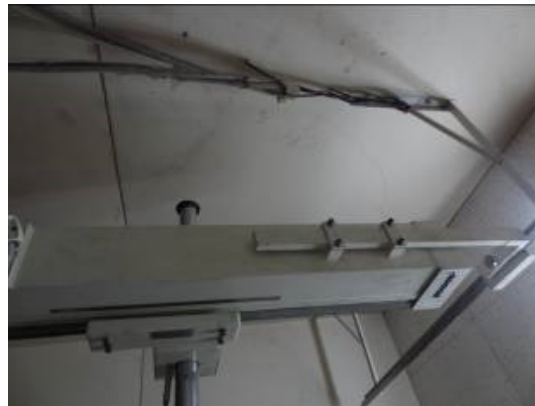
Figure 23: X-Ray equipment attached to the roof

Medical equipment and storage systems in the Emergency (Surgical) Block, designed and constructed with JICA support and to Japanese codes and standards, are secured or anchored for protection against earthquake shaking. The X-ray imaging equipment is fixed to the roof (Figure 23: X-Ray equipment attached to the roof) and rails are embedded in the floor and walls (Figure 24). However, the control equipment is freestanding and could topple and be damaged in earthquake shaking (Figure 25 left). Some of the imaging equipment such as the Ultrasonography (USG) machine are on rollers, and if these are not kept locked in position they could roll during an earthquake and lose functionality for post-earthquake diagnostic use (Figure 25 right).

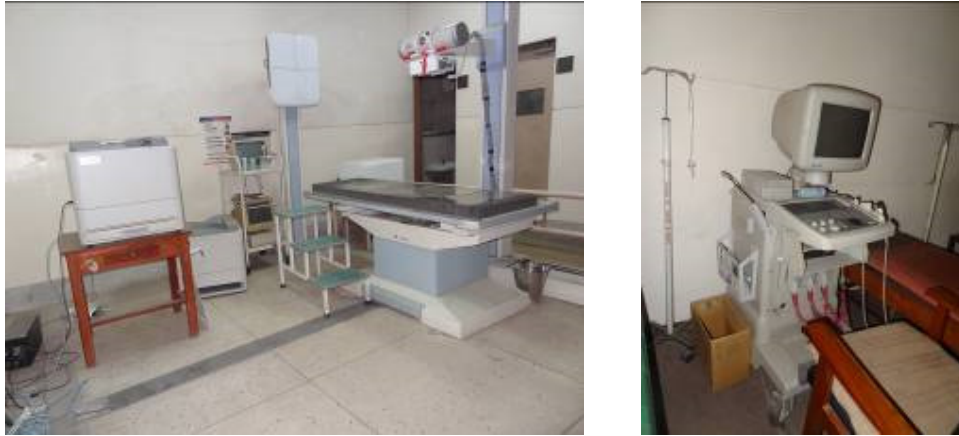
Figure 25: Ancillary equipment that could topple or slide(left) and equipment on rollers (right)

The hospital needs to make an inventory of the most critical medical equipment and determine whether or not it is adequately anchored/ protected against seismic forces. Most of the equipment in the Medical Ward Block needs to be anchored. For any new equipment, seismic anchorage should be included as part of the purchase contract. The furnishings in the Medical Ward Block, and the later additions in the Emergency (Surgical) Ward, have no anchorage and in many cases have been located in such a manner that these will cause injuries and/or hinder a smooth exit during earthquake shaking. The hospital staff needs to be educated about the damage that displaced equipment can cause due to earthquake shaking, and must understand the intent behind various anchoring measures built into the equipment, contents and furnishing in the Emergency (Surgical) Block.

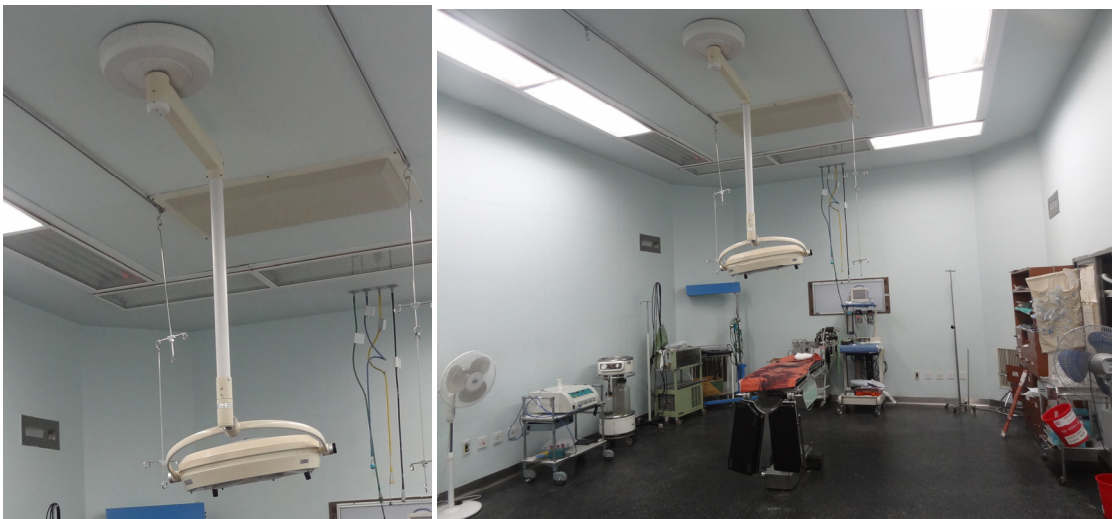
Figure 26: Operation Theatre (left) and anchoring of OT lights (right)

In the Operation Theatres, lamps, anesthesia equipment and surgical tables are in good condition, and operational (Figure 26, left). It was reported that the OT lights are firmly secured to the roof slabs, but the appropriateness and depth of the anchor bolts for the long extended arms needs to be ascertained to ensure stability of this critical equipment (Figure 26, right). Ancillary equipment in the OT is not secured and may topple or slide in earthquake shaking (Figure 27 left). Heavy stainless steel storage cupboards with glass fronts are placed next to walls but not secured to them. Several items are stored on top of these cupboards and these would easily slide off in moderate earthquake shaking (Figure 27 right).

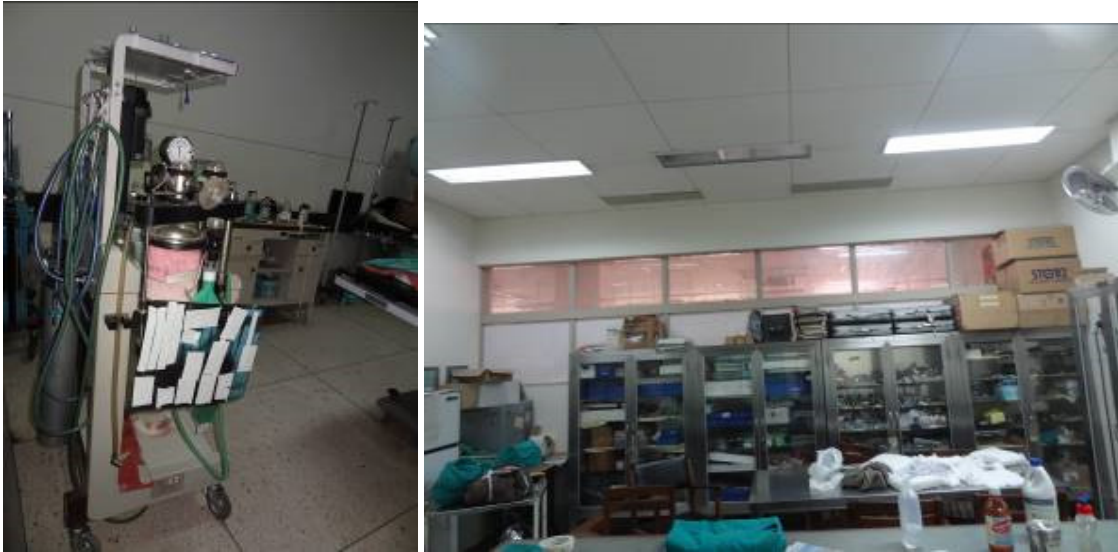
Figure 27: Equipment on rollers in OT (left); partial height infill wall with storage units lined against it (right)

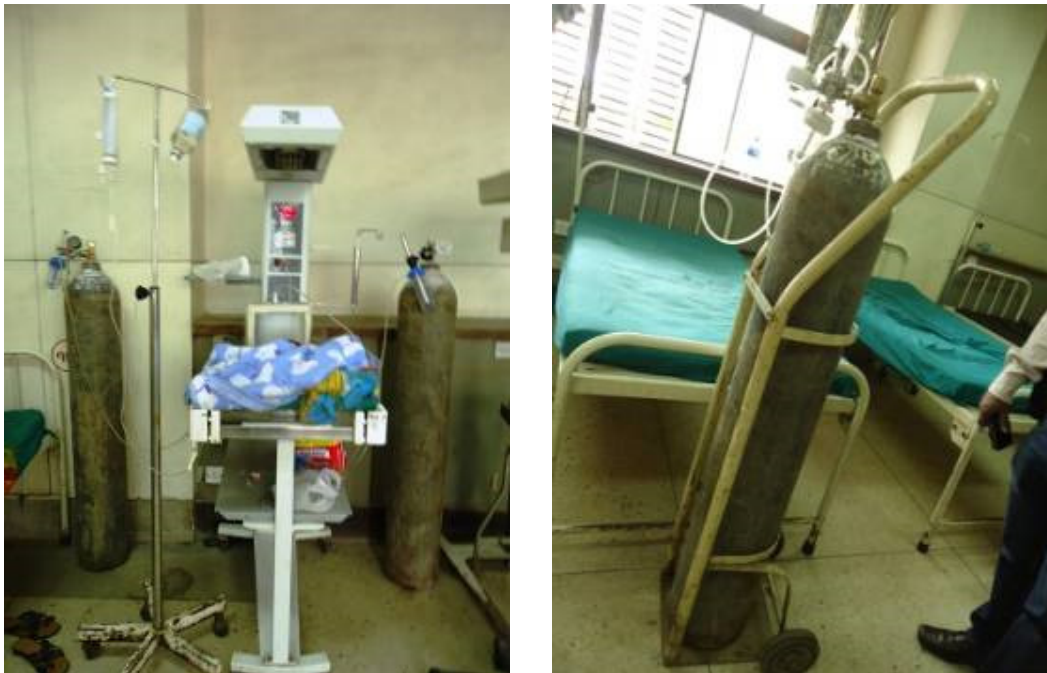
Oxygen cylinders either free standing or on trolleys, are located in the wards and in the intensive care units, near bedsides and exits. They could fall or topple and block exits or cause leakages and injuries (Figure 28). Storage of unrestrained oxygen cylinders in several locations near the OTs and other critical areas of the hospital poses a serious threat, as toppling of these cylinders would likely block exits and impede evacuation and egress of the critically ill (Figure 29).

Figure 28: Unrestrained oxygen cylinders in ICU (left) and cylinders in wheeled carriers not fastened with the bed in Emergency Block (right)

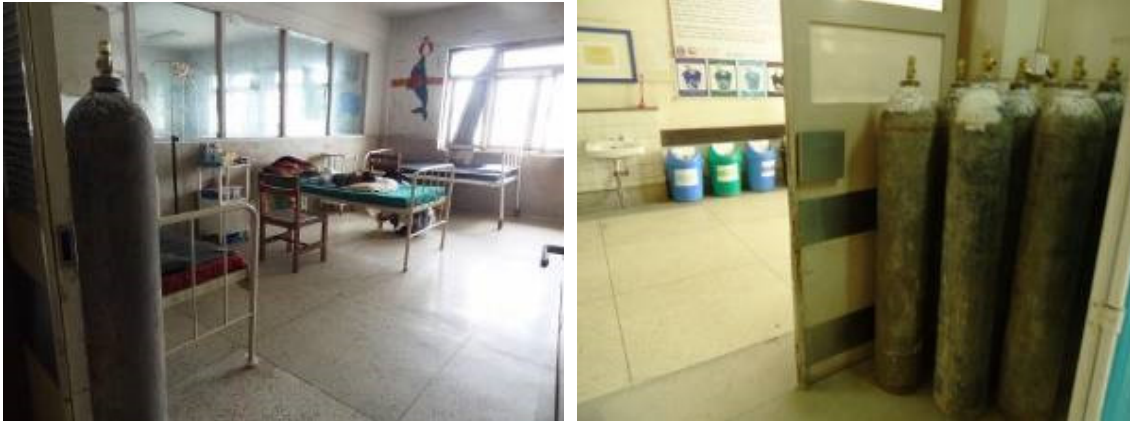
Figure 29: Unrestrained cylinders blocking egress in OT and Burn Ward

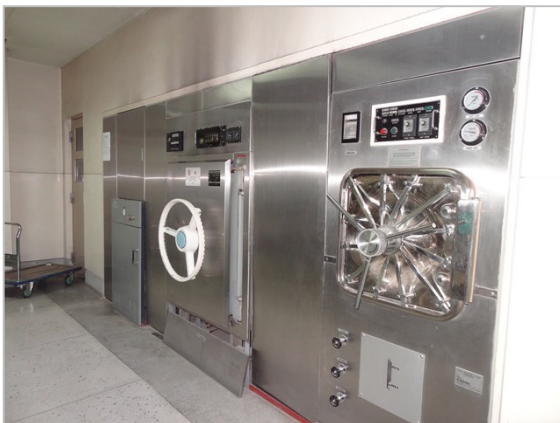
Figure 30: Autoclaves

The Central Sterile Supplies Department (CSSD), where all instruments and equipment are sterilized and stored, is a critical facility for any hospital. The Kanti Children's Hospital uses two large autoclaves (Figure 30) and three mini autoclaves for sterilization of equipment. The main autoclaves in the CSSD have been encased and bolted to the ground to prevent lateral movement in earthquake shaking. The connecting water pipes have vertical supports but no lateral bracing for seismic forces (Figure 31). The pipes do not have flexible connectors and could break during strong shaking if the vertical supports permit significant lateral movement, but a detailed evaluation (outside the scope of this assessment) would be necessary to determine the likelihood of pipe breakage. If they occurred, pipe breaks would cause water leaks and disrupt the functioning of the CSSD (Figure 32).

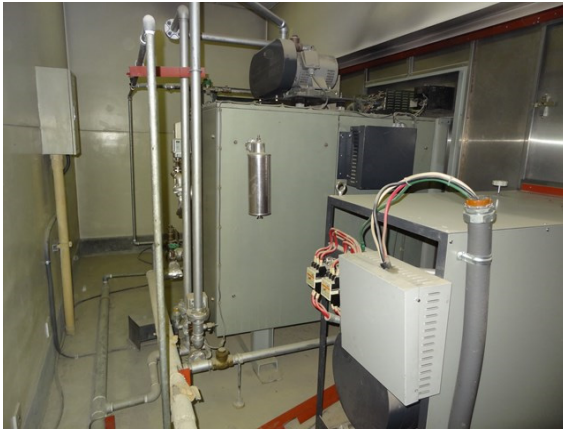
Figure 32: Lack of flexibility in the supply pipes

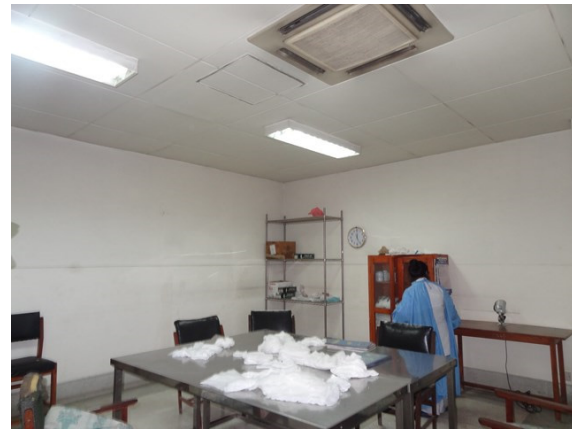
The sterilized equipment, cloths, gloves, and other materials are sorted and dispatched to various departments in a large room within the CSSD. This room has a few racks and cupboards that could topple in earthquake shaking (Figure 33). The CSSD has a suspended ceiling which conceals the air-conditioning ducts and lighting lines. The three mini autoclaves are placed on counter tops with no restraining elements; these could slide and fall in lateral shaking. The entry to the CSSD and the windows has glass panels that could break and impede egress.

Figure 33: Central sorting and dispatch room with unrestrained shelves

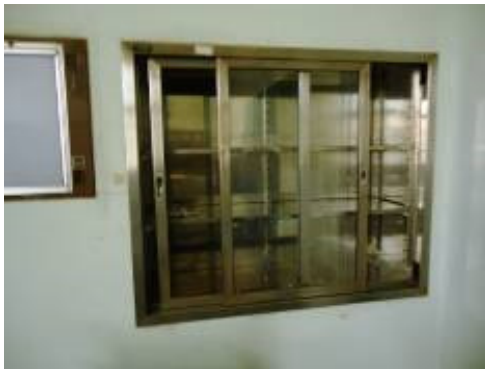
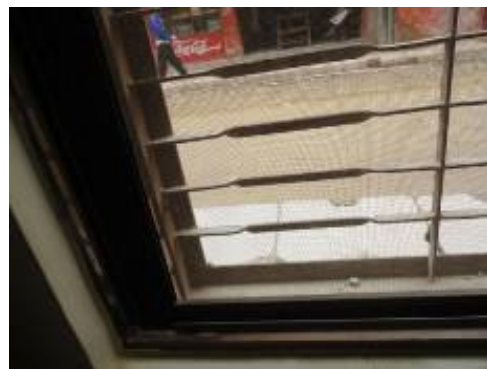
Figure 34: Inbuilt storage (left) and wire mesh panels to prevent falling hazards due to shattering of glass (right)

There are several examples of good practices in a number of areas in the hospital. These include built-in storage with sliding glass doors that will not topple or slide, and that will not cause spillage or damage to contents (Figure 34 left). The glass windows have a layer of protective metal mesh panelling to prevent the glass from shattering and falling inside (Figure 34 right). The shelving system in the Diagnostic Laboratory has an additional vertical support from the roof and restraining bars on the front of the shelves to prevent toppling of shelves and spillage of contents (Figure 35). The rails for curtains in the wards are well connected with the framework of the suspended ceiling through vertical and diagonal ties (Figure 36).

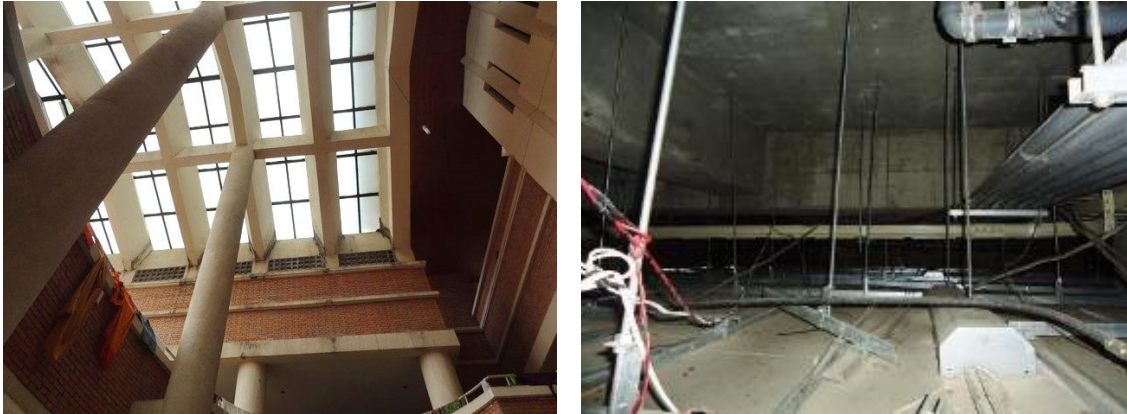
The architectural shell of the Emergency (Surgical) Block— built as per Japanese code provisions —is expected to experience little damage in moderate earthquake shaking. However, the central courtyard near the reception area has a sun roof which could be damaged and result in broken glass in the entrance hall courtyard, an area used by patients' parents for resting, drying clothes and other such activities (Figure 37, left). The suspended ceilings are connected with the slab through vertical anchors (Figure 37, right)). However, there is no lateral bracing against earthquake forces. While the ceilings might swing and become damaged, this type of suspended ceiling is relatively less vulnerable than some other types. Any large areas of suspended ceiling should be investigated in further detail, as these are more prone to earthquake damage.

Figure 37: Sun roof over central atrium (left); Suspended ceiling hung from roof slab but not laterally braced (right)

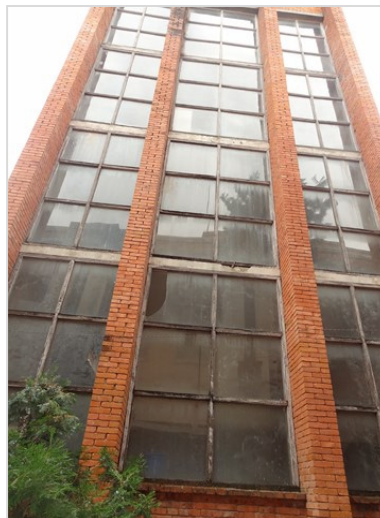
In the Medical Ward Block, the masonry infill walls are not attached to the frame and could crack and fall during strong earthquake shaking. Many partition walls are also made of unreinforced masonry and could be similarly affected. Falling masonry is a threat to those nearby and affects the ability of medical staff to work in disrupted areas. Some exterior walls of the Medical Ward Block have large glass panels, especially at the staircase adjoining the open courtyard (Figure 38).

Figure 38: Large glass panels on Medical Ward Block possibly susceptible to breakage from building sidesway

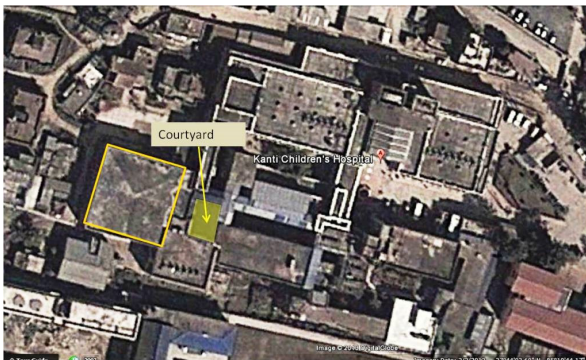
The Annex Ward, built in 2007, was constructed next to the old Medical Ward Block. Due to an oversight, there is no access to the courtyard between the Annex and the older building (Figure 39). As a result, this courtyard has become a dumping area, overgrown with tree-size weeds and overflowing wastewater pipes. The lack of access means that this courtyard cannot be maintained on a regular basis and is also a breeding ground for mosquitoes, a highly undesirable condition in the country's only referral hospital for children (Figure 40). Access to this courtyard should be immediately ensured, at the cost of one or two rooms, so that the courtyard can be converted into a positive outdoor space like other such enclosed courtyards in the hospital.

Figure 39: Internal courtyard with no access at ground level

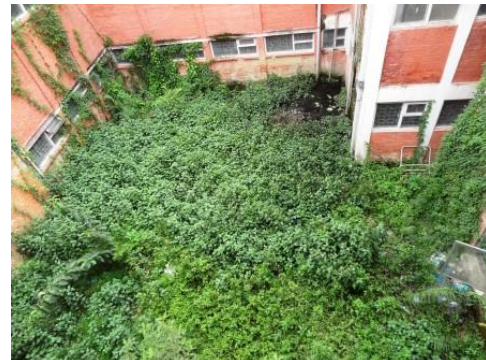
Figure 40: Internal courtyard without access at ground level and no maintenance
