Initial Seismic Vulnerability Assessment of Jigme Dorji Wangchuck National Referral Hospital Thimphu, Bhutan

July 31, 2012

Prepared for the World Health Organization Regional Office for South-East Asia by

GeoHazards International
A Nonprofit Working Toward Global Earthquake Safety

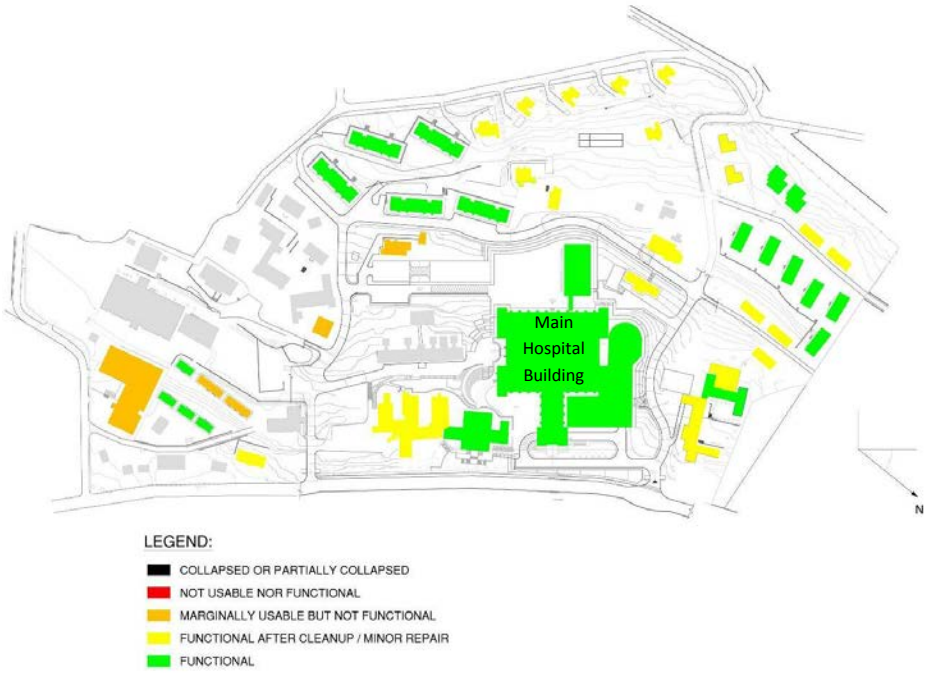
Site plan showing likely performance of hospital buildings in M6.1 hypothetical scenario earthquake

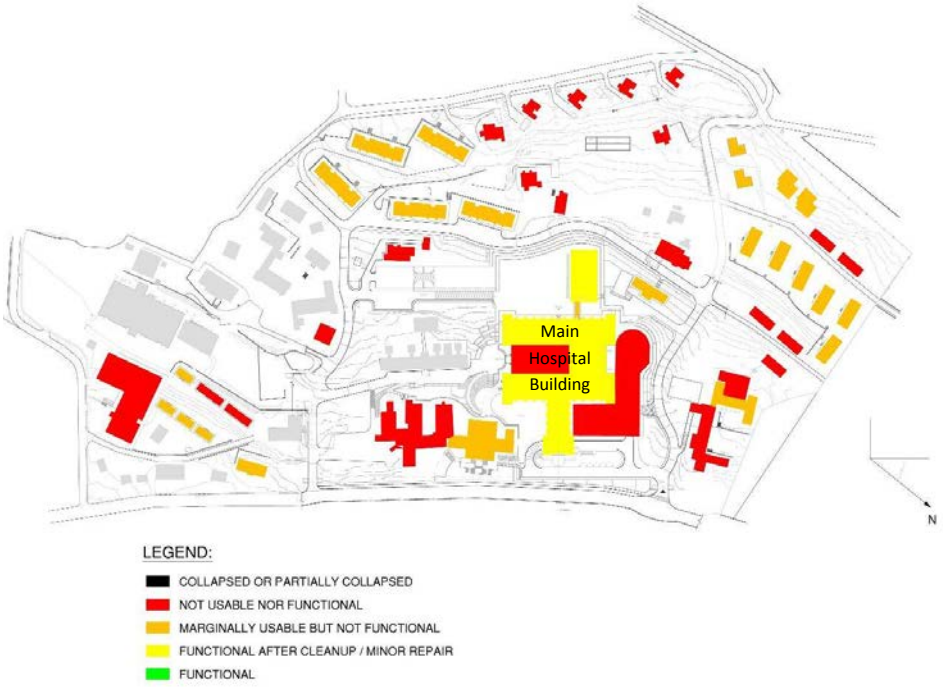
Site plan showing likely performance of hospital buildings in M7 hypothetical scenario earthquake

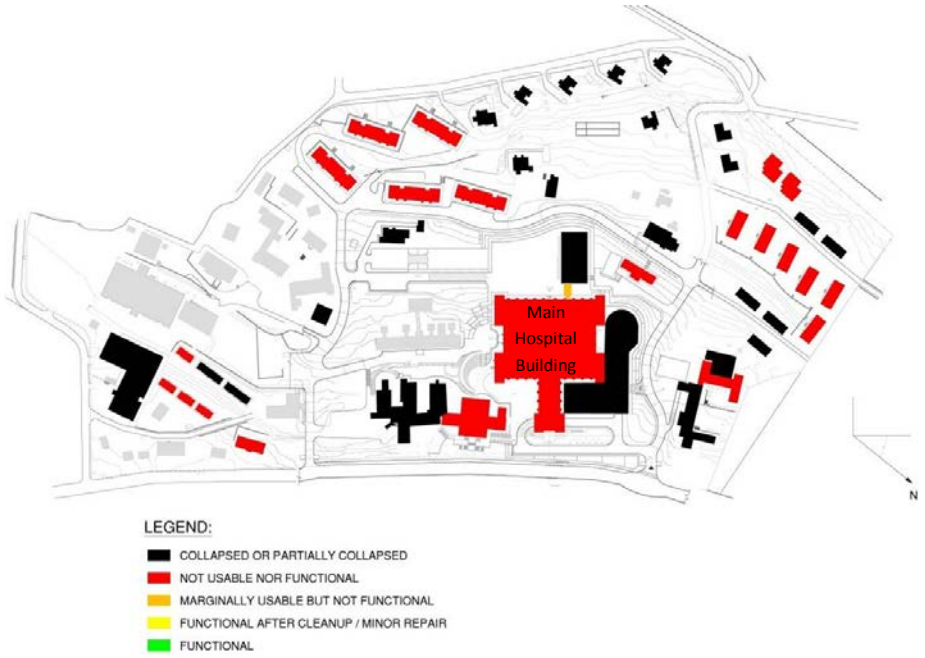
Site plan showing likely performance of hospital buildings in M8.6 hypothetical scenario earthquake

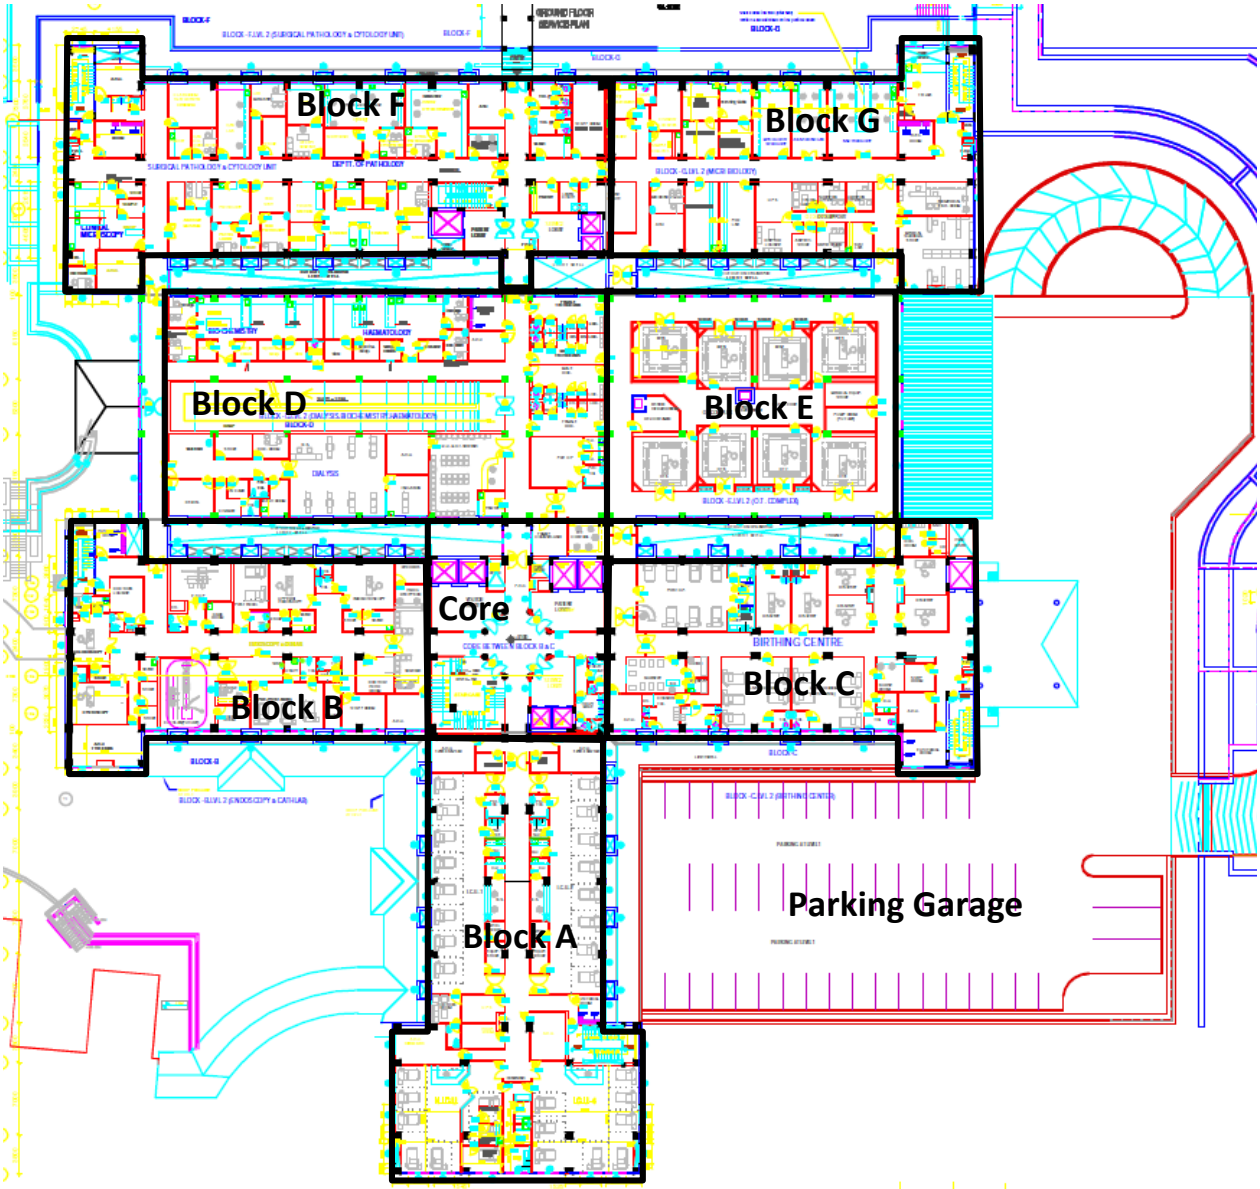
Figure 7. Plan of main hospital building showing Blocks A-G

While the building appears highly irregular in plan, it consists of eight relatively regularly shaped blocks (Blocks A-G, plus a core) separated by seismic joints, as Figure 7 (following page) shows. Per the Indian Standards, these joints should be 100mm. The building has a steel roof truss covered by corrugated metal roofing. At the roof levels, there are concrete beams in both directions below the roof trusses, but no concrete slabs that would act as a diaphragm (a horizontal structural member that distributes earthquake forces to the building's frames and/or walls).

Table 2 on page 19 summarizes the damage states (defined in Table 1) for the main hospital building's blocks and the parking garage. The building is not likely to suffer significant life-threatening structural damage in any of the three hypothetical scenario earthquakes being used for discussion purposes in this

report. The building's brick infill walls and partitions will tend to crack, when any floor in the building moves horizontally more than 1% of the floor-to-floor height, and partitions are likely to fail during strong shaking. Although not so serious as a partial structural collapse, such failures could cause serious injuries, particularly to immobile patients. Determining the level of earthquake shaking at which such cracking would occur requires a detailed computer analysis, which is beyond the assessment's scope.

Damage to partitions and infill walls, along with isolated partition failures (most likely in the upper storeys), as well as some minor damage to the reinforced concrete frame may begin to occur in an earthquake the size of the M7 hypothetical scenario earthquake. In the M8.6 hypothetical scenario earthquake, the main building's concrete frame may experience damage at the ends of beams, and the brick infill walls are likely to suffer heavy damage, but the building should retain its structural integrity

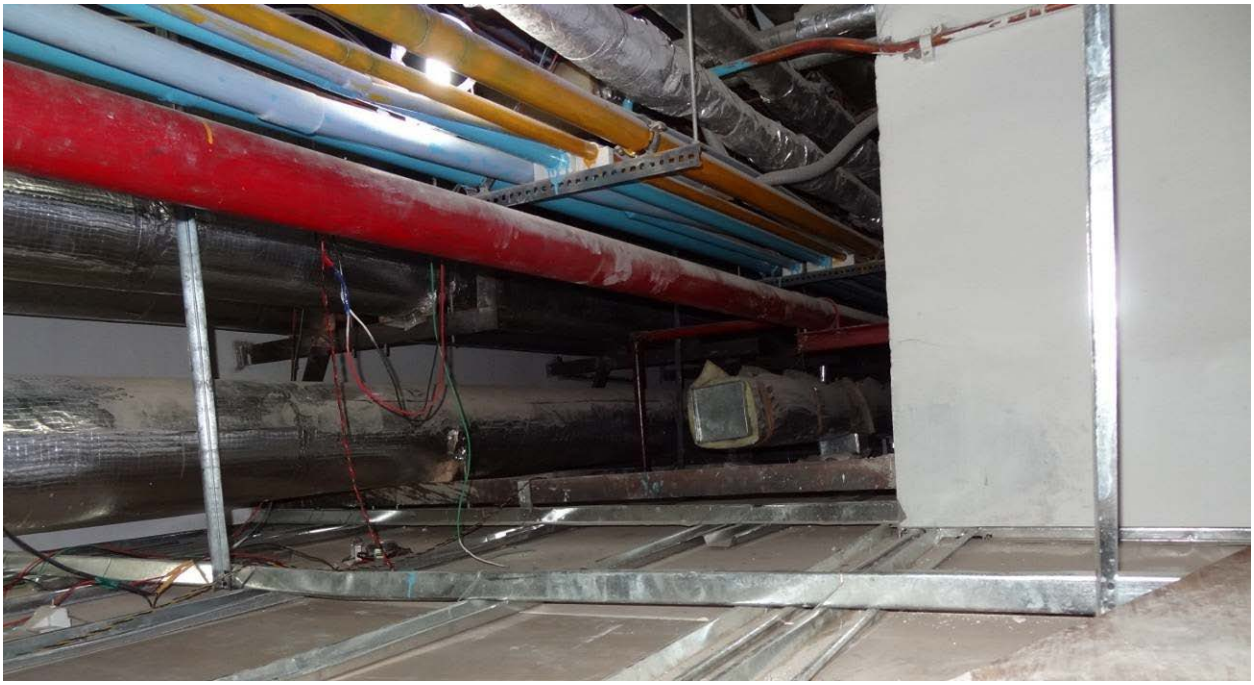
The main hospital building has suspended ceilings, constructed of panels that are screwed to a light metal frame hung from the floor slab above. The ceilings span from partition to partition. Figure 44 shows a typical suspended ceiling support system, which has no lateral bracing, and which also has unbraced utility service pipes for domestic water, fire suppression water, medical gas and steam. While these ceilings are more robust than lay-in acoustical tile ceilings prevalent in other areas, they are still prone to damage, if the partitions that provide lateral bracing collapse.

Figure 44. View above suspended ceiling showing support system and utility services. There is no lateral bracing for the suspended ceiling, fire and domestic water pipes, medical gas lines and steam pipes.

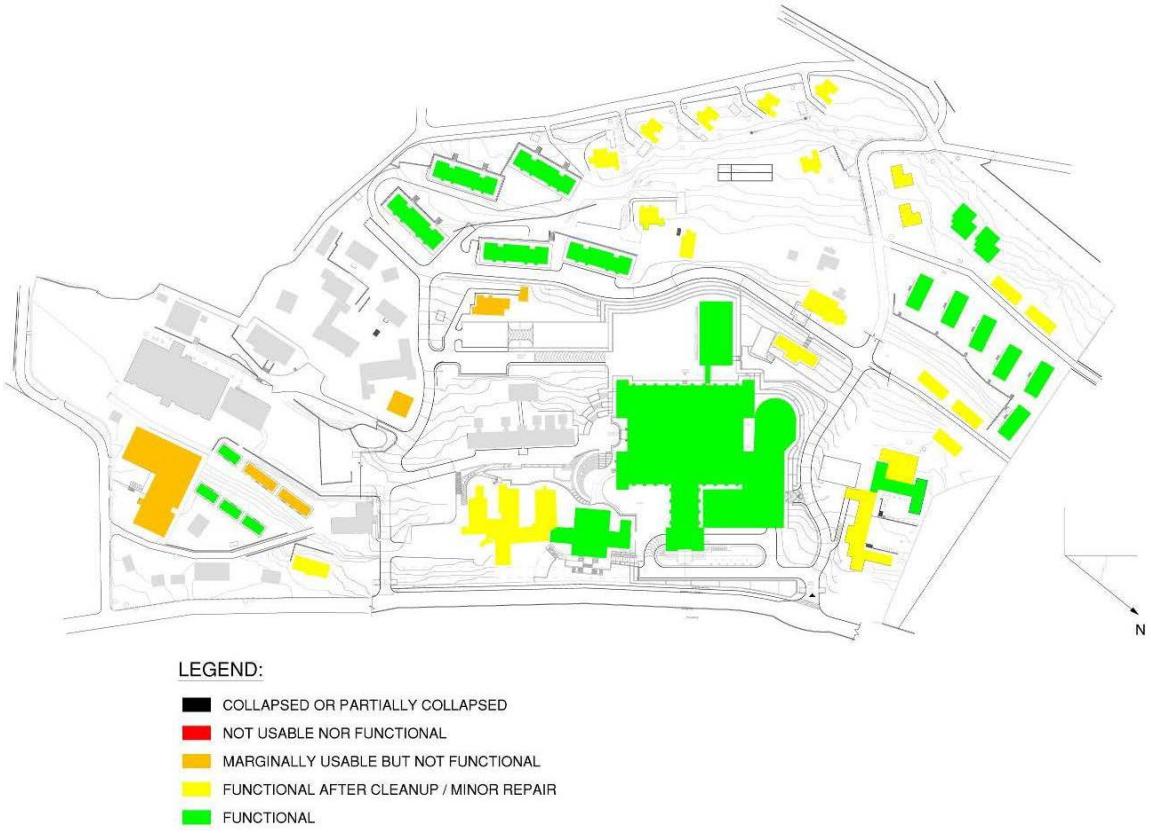
Figure 46 (following page) shows the anticipated performance of the hospital's buildings, in terms of functionality. The actual state of functionality is highly uncertain, due to uncertainty in the exact nature of ground shaking and in the team's existing knowledge of structural and nonstructural systems. Each building could be one performance level higher or lower than shown. One performance level is shown for illustrative purposes. Short term interruptions of services that do not require evacuations are not considered.

Figure 46. Site plan showing performance of hospital buildings in M6.1 hypothetical scenario earthquake

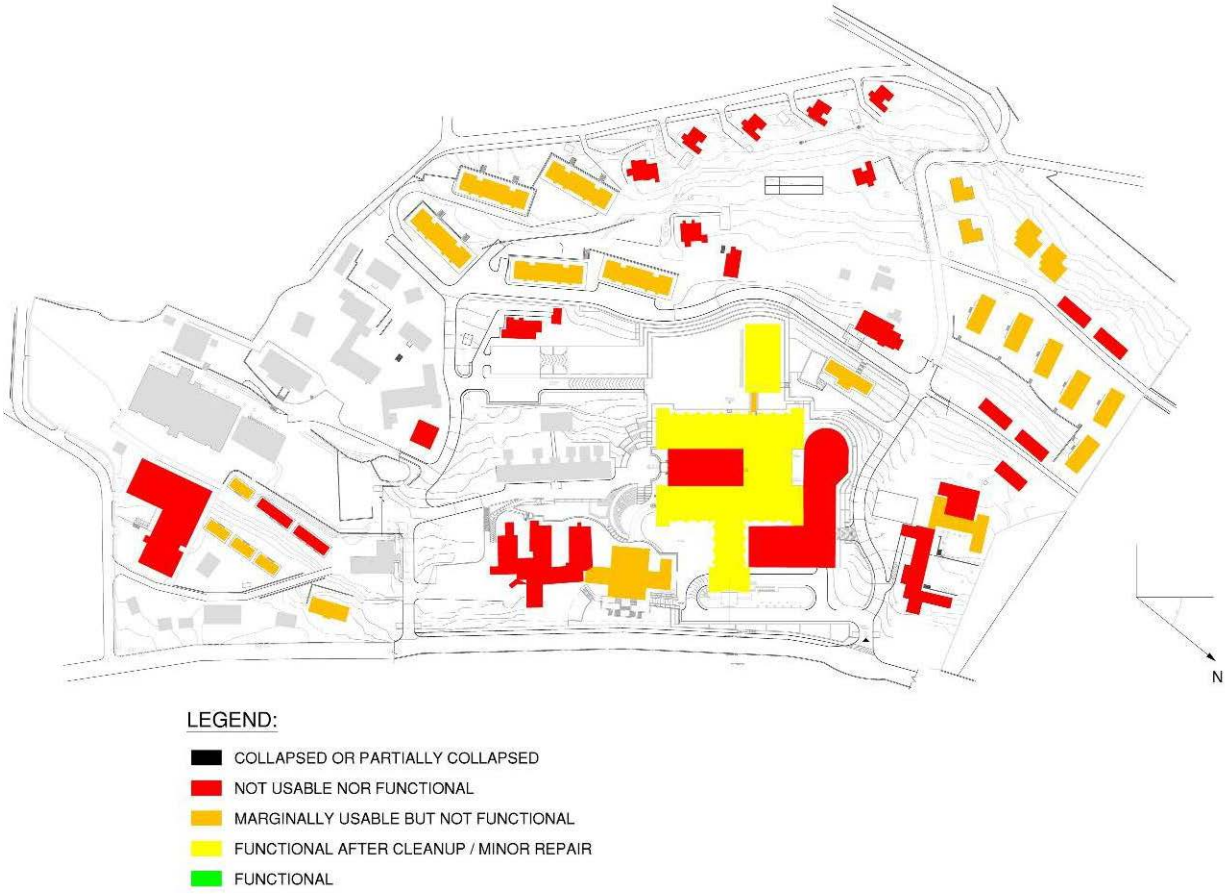
Figure 48 (following page) shows the anticipated performance of the hospital's buildings, in terms of functionality. The actual state of functionality is highly uncertain, due to uncertainty in the exact nature of ground shaking and in the team's existing knowledge of structural and nonstructural systems. Each building could be one performance level higher or lower than shown. One performance level is shown for illustrative purposes. Short-term interruptions of services that do not require evacuations are not considered. Most areas of the main hospital building would be functional after some cleanup, but the lack of medical gas limits certain essential functions. Damage to the ramp block and lifts impedes the movement of patients between floors. Some staff quarters, the central medical store, the old building and the community health buildings are all heavily damaged and may be unsafe to use. The hospital is able to deliver some essential care for a limited time period, until the generator fuel and water supply run out.

Figure 48. Likely performance of hospital buildings in M7 hypothetical scenario earthquake

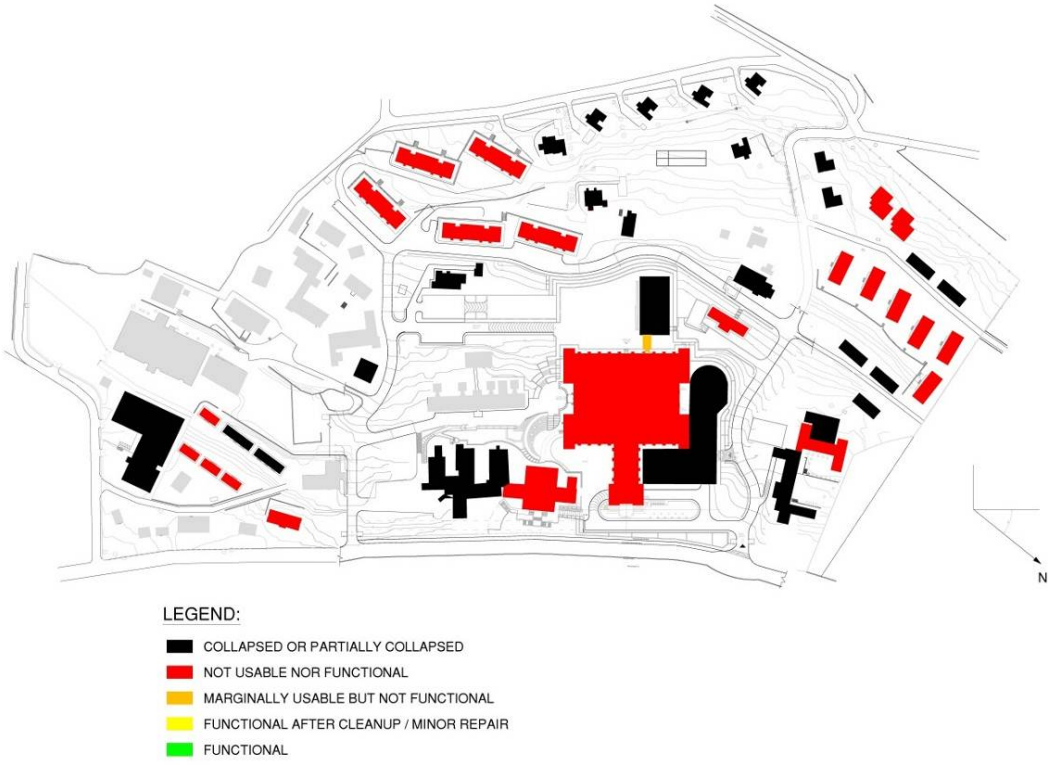
Figure 50 below shows the anticipated performance of the hospital's buildings, in terms of functionality. The main hospital has not collapsed and has protected the lives of most inside, but a number of other buildings at the site may have collapsed. The hospital is able to provide austere care in the immediate post-earthquake period. The main building may be repairable, but the damage is extensive and full repairs would take months or longer.

Figure 50. Likely performance of hospital buildings in M8.6 hypothetical scenario earthquake
