Initial Seismic Vulnerability Assessment  
of Equipment, Utilities,  
Architectural Shell and Contents  
at  
Paropakar Maternity and Women's Hospital  
Thapathali, Kathmandu, Nepal

July 31, 2013

Prepared for the World Health Organization Regional Office for South-East Asia by

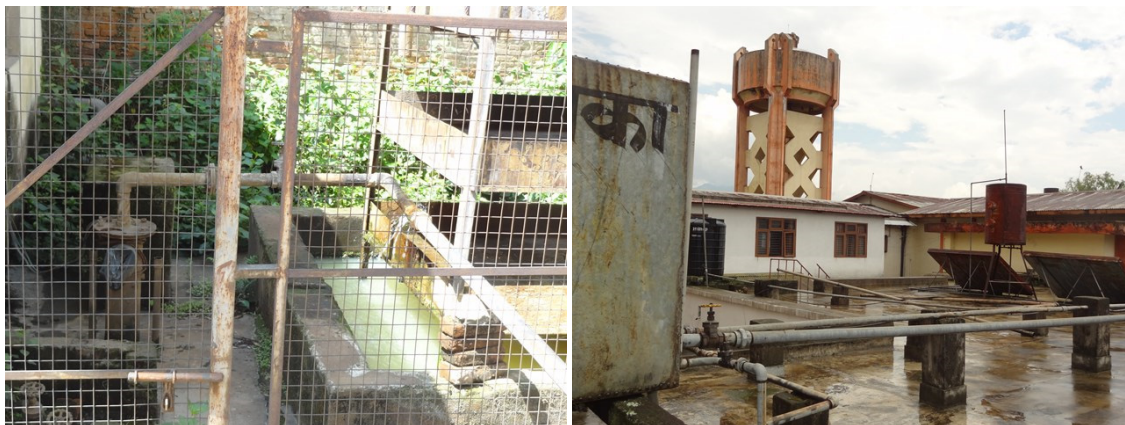
The hospital does not depend on the Municipal water distribution system. Water is drawn from two bore wells from aquifers 100-200m below ground level through submersible 15Hp pumps (Figure 9). Another two bore wells have recently been commissioned with a manual and motor operated pump each. The raw water is stored in an underground water tank of 20,000L capacity, where chlorination is added. The hospital has a Filtration Unit, which is not in working condition. Chlorine gas is stored in 50L jars, but none were present at the time of the team's visit. From the underground water tank, after chlorination, the water is pumped up for storage in a Tower Tank of capacity 80,000L. This chlorinated water is pumped to the Overhead Water Tanks (Figure 9) located on the roof of the different building blocks, namely, Emergency Block (4 tanks of 2000L each), New Block (3 tanks of 2000L each), New Ward Block (10 tanks of 2000L each), Old Block (4 Galvanised Iron (GI) tanks of 2000L each), and Obstetric OPD Block (6 tanks of 2000L each). The rooftop overhead tanks have a combined capacity of 54,000L. The daily demand for water in the hospital is about 80,000L. There are two pumps of 5Hp capacity each, out of which one is in operation while one is always held in reserve and tested periodically.

Figure 9 : Bore well (left); view of the Tower Tank and rooftop overhead water tank (right)

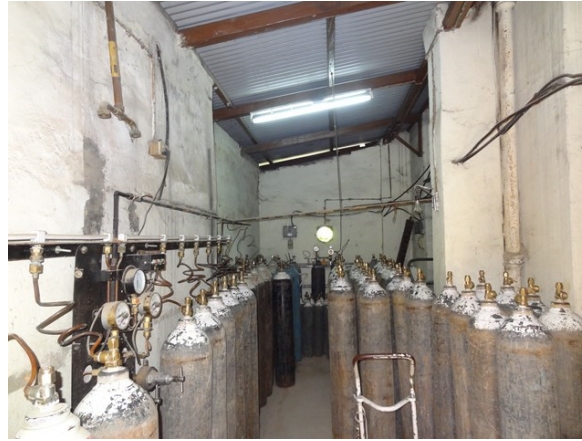
Figure 10: Oxygen Manifold

Medical gas is supplied via oxygen cylinders that are brought in by a supply company truck on a daily basis. The hospital does not have a bulk oxygen tank. Piped oxygen is provided to the OTs and critical areas through a manifold that is fed by 15 cylinders (Figure 10). Piping for nitrous oxide and vacuum (suction) exists but neither is in working condition.

that may suffer earthquake damage that would disrupt the oxygen supply system. Oxygen and other medical gas cylinders are not restrained in any of the storage locations in the hospital.
