# Delhi Secretariat (Dilli Sachivalaya)

## *A Summary of the Seismic Evaluation and Retrofit Process*

### *Delhi Earthquake Safety Initiative for Lifeline Buildings*

**December 15, 2008**

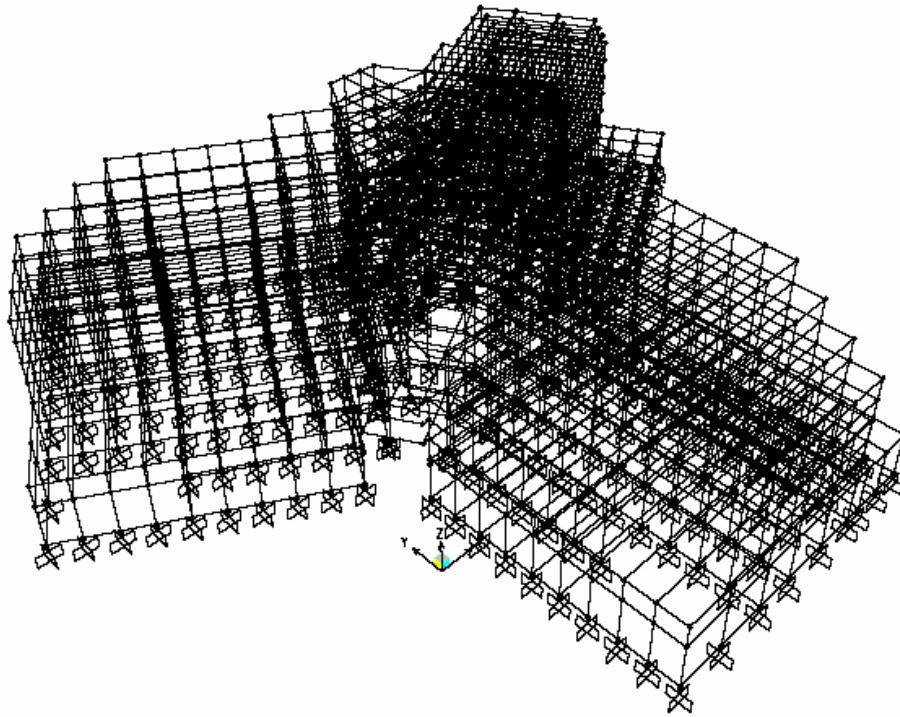
**Figure 6. Three-dimensional model of the building**

IIT Chennai's findings included the following major points:

- The piles in the central core and some in the blocks fail in axial compression before the DBE target displacement. Accurately modeling pile capacity is critical to obtaining meaningful results.
- Upper storey columns fail before the DBE target displacement because of inadequate reinforcement. A storey mechanism forms in the top storey.
- Pounding will occur between the wings and core, due to insufficient seismic separation.
